<b>ANGELINA &amp; NECHES RIVER AUTHORITY</b>
	<b>2012 Basin Highlights Report</b> For the Upper Portion of the Neches River Basin

<p><b>2012 Upper Neches Basin Highlights Report</b></p> <p>The 2012 Basin Highlights Report was prepared by the Angelina &amp; Neches River Authority in cooperation with the Texas Commission on Environmental Quality (TCEQ) under the authorization of the Texas Clean Rivers Act.</p>	<p>Angelina &amp; Neches River Authority P.O. Box 387 • Lufkin, TX 75902 936-632-7795 • 800-282-5634 <a href="http://www.anra.org">www.anra.org</a> • <a href="mailto:info@anra.org">info@anra.org</a></p> <div data-bbox="1348 1096 1595 1172">

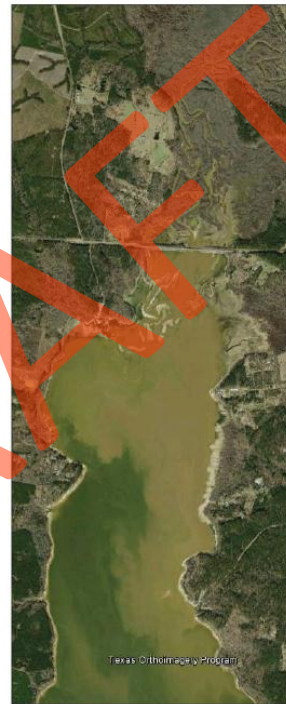
Attoyac Arm of Lake Sam Rayburn (Hwy 103 crossing)  
January 2009

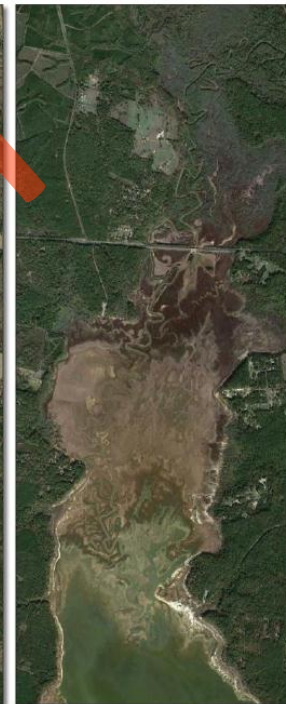
Attoyac Arm of Lake Sam Rayburn (Hwy 103 crossing)  
November 2011

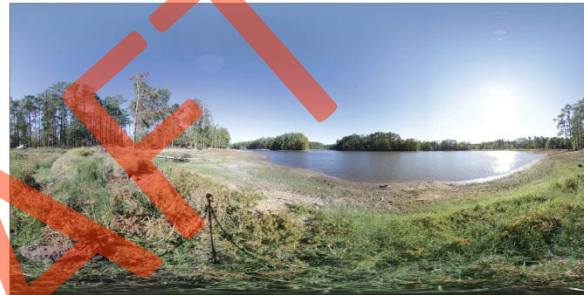
Lake Ratcliff  
November 2011

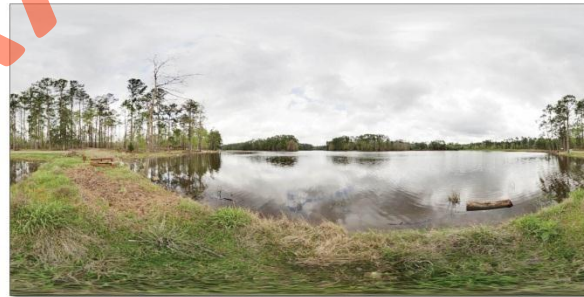
Lake Ratcliff  
March 2012

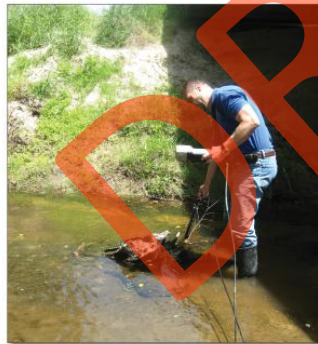
Measurement of pH, DO, Specific Conductance, and Temperature using a multiprobe instrument

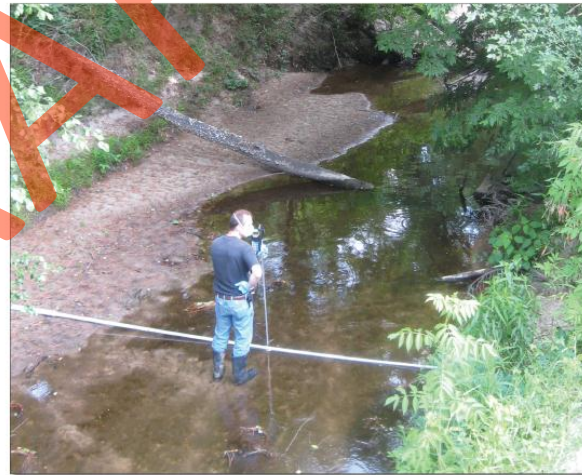
Measuring flow

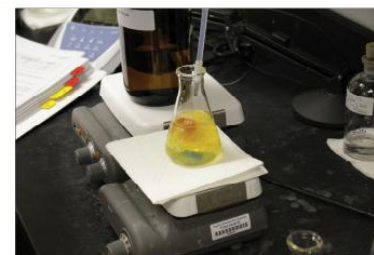
Analysis of Chloride by Titration

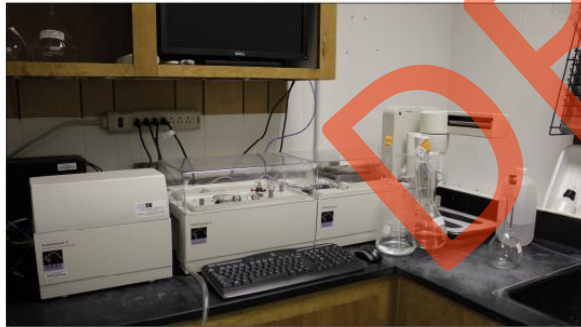
Seal AutoAnalyzer 3 for automated nutrient analysis

At the end of FY 2011, the ANRA Environmental Laboratory, with assistance from the Texas Clean Rivers Program, was able to purchase a Seal AutoAnalyzer 3. The AutoAnalyzer 3 is a fully automated Continuous Flow Analyzer for the determination of nutrients in environmental waters. This system is capable of running multiple methods for numerous parameters, offers high sample through-put and an autosampler for unattended analysis, and can reach detection limits that are much lower than we are able to achieve with our current instruments. The AutoAnalyzer will allow the ANRA Environmental Laboratory to reach the lower detection limits for Total Phosphorus being proposed by the TCEQ (0.02 mg/L, vs the current limit of 0.06 mg/L).

The ANRA Environmental Laboratory is currently in the process of analyzing Proficiency Test samples using the new methods. In order to be accredited for these methods by TCEQ, the laboratory must successfully complete two rounds of Proficiency Test studies. With each Proficiency Test study lasting 45 days, and a requirement of at least 15 days between the end of one study and the beginning of the next, this process will last several months. After the Proficiency Test samples are analyzed, the laboratory can submit the documentation to TCEQ for accreditation.
