Lake Sam Rayburn On-Site Sewage Facility (OSSF) Program Support and Attoyac Bayou OSSF Remediation FINAL REPORT

FINAL REPORT August 2016

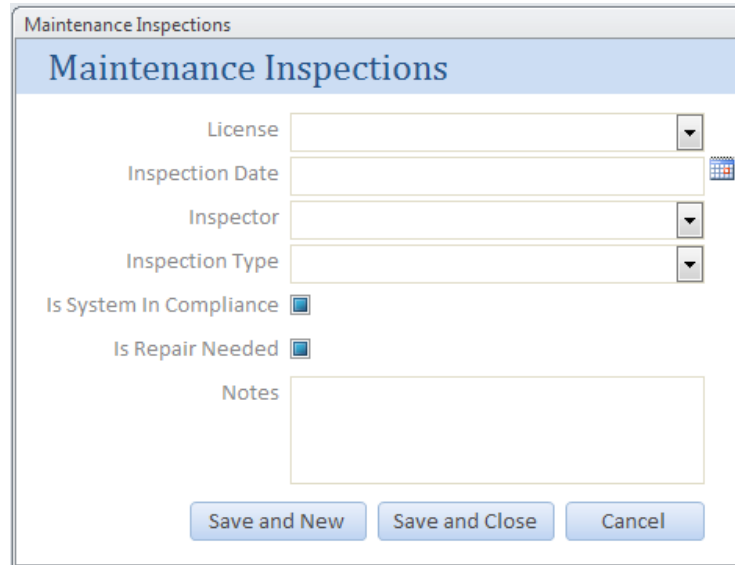
The Maintenance Inspection screen allows the user to enter information from maintenance inspections as provided to ANRA by contractors. The maintenance inspections are linked to the OSSFs by the license number.

The screenshot shows a window titled "Maintenance Inspections" with a blue header. The form contains the following fields and controls:

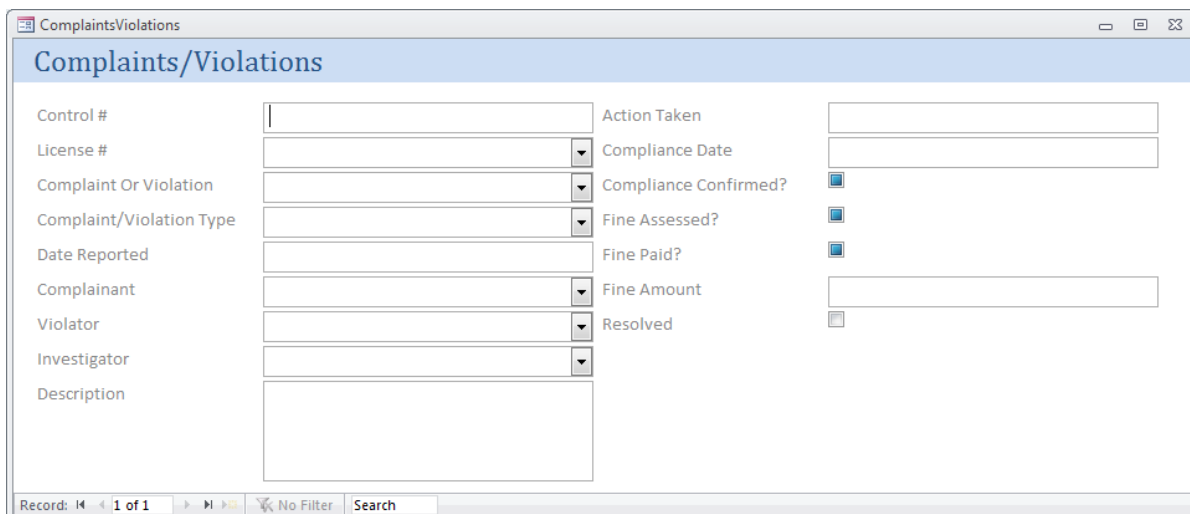
The Complaints screen allows for the documentation of information related to complaint investigations. Complaint investigations can be linked to individual OSSFs using the license number.

The screenshot shows a window titled "Complaints/Violations" with a blue header. The form is organized into two columns of fields:

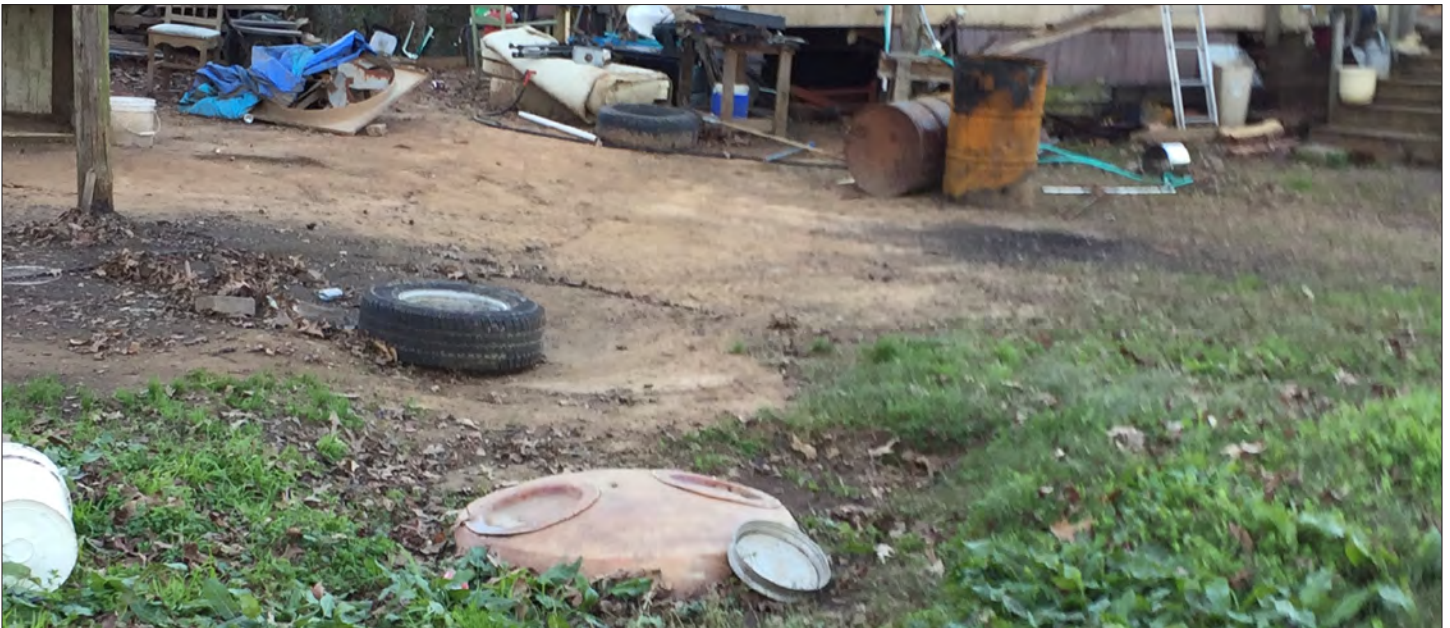
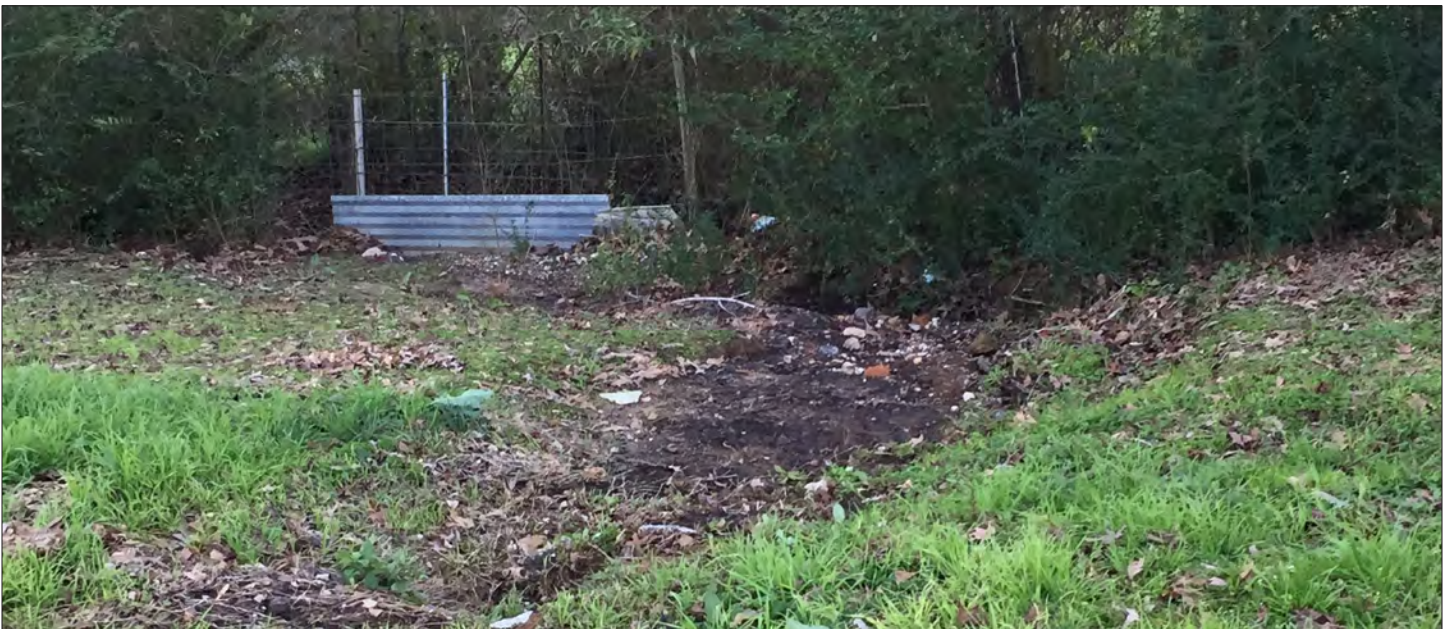
Due to the fact that multiple homes were being serviced by the same failing conventional system, it was determined that the best course of action would be to install two aerobic OSSFs on the property. A 500-gpd OSSF was installed to treat sewage discharge from the main residence, and a 750-gpd was installed for treatment of sewage from the other two households. The existing system was pumped and closed.

Site photographs of NAC-001 RT and NAC-002 RT property prior to installation

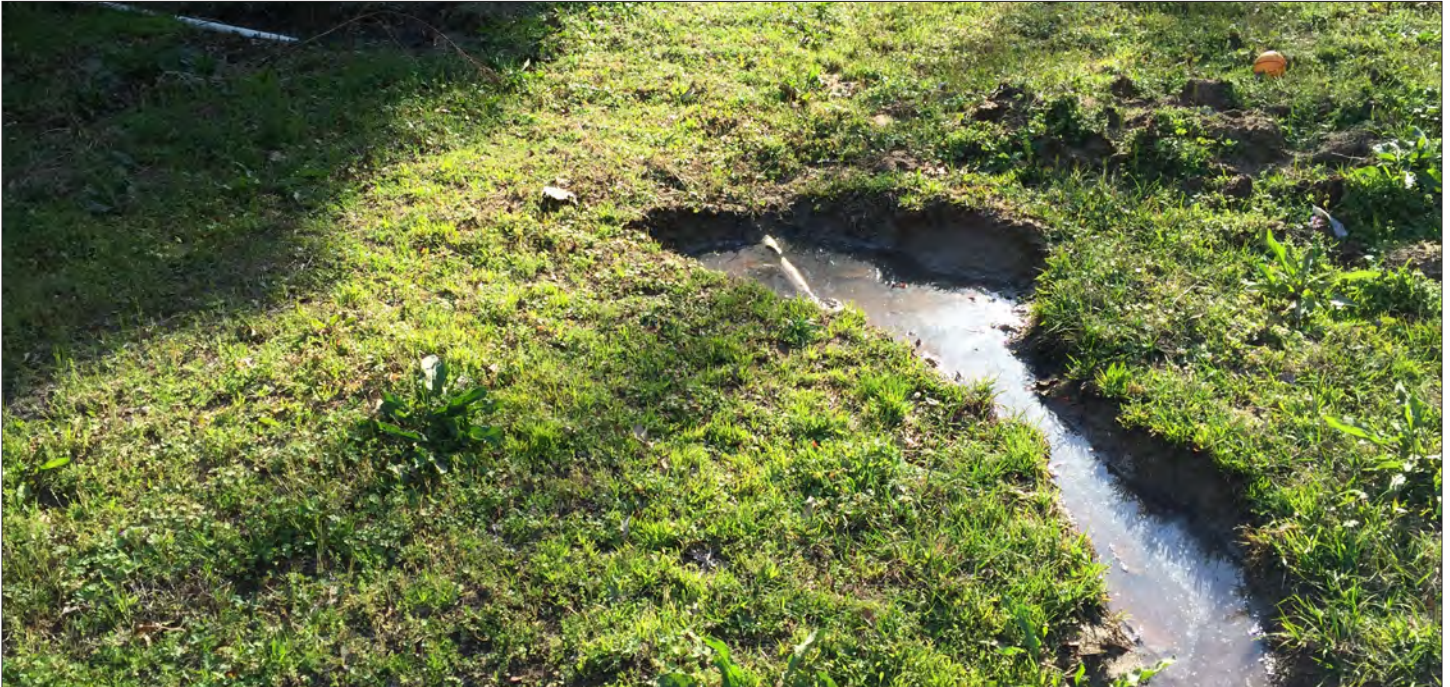
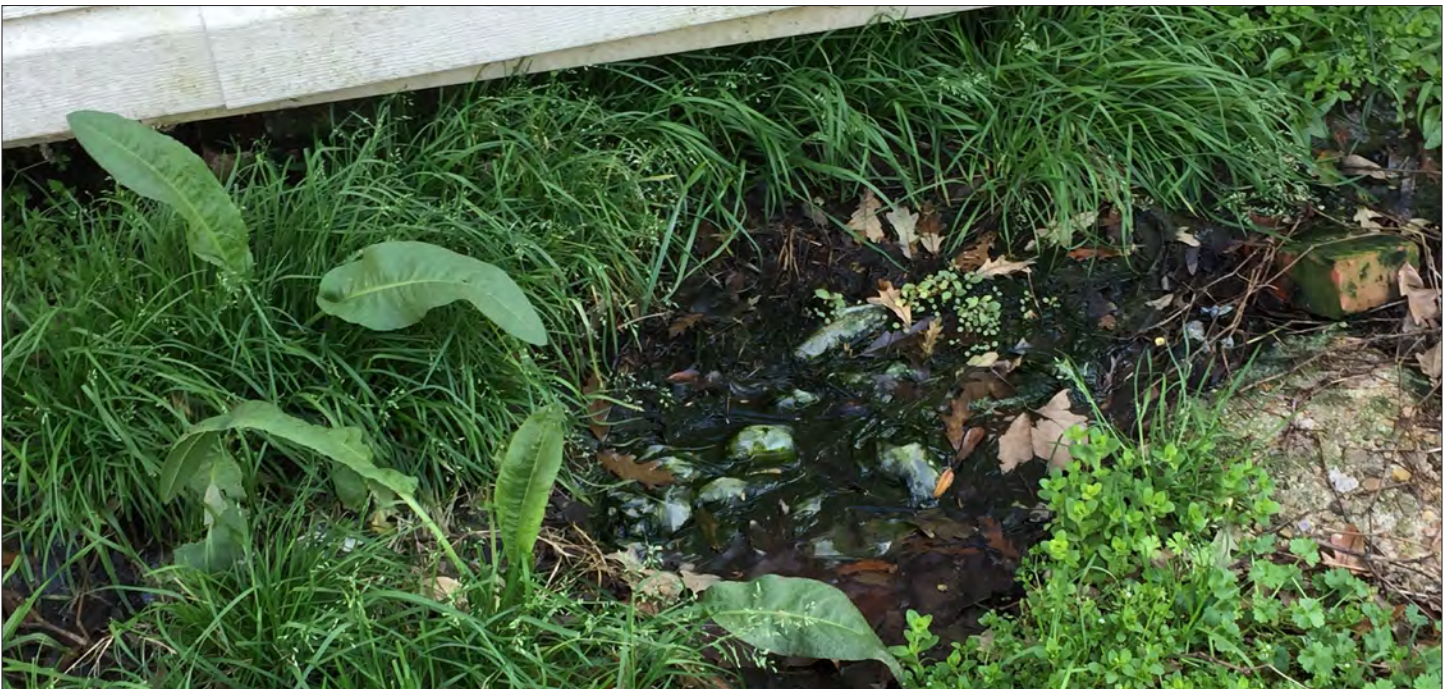
A 500-gpd system was installed at this property based upon the system design. The existing conventional system was pumped and closed.

Site photographs of NAC-004 JDV property prior to OSSF installation

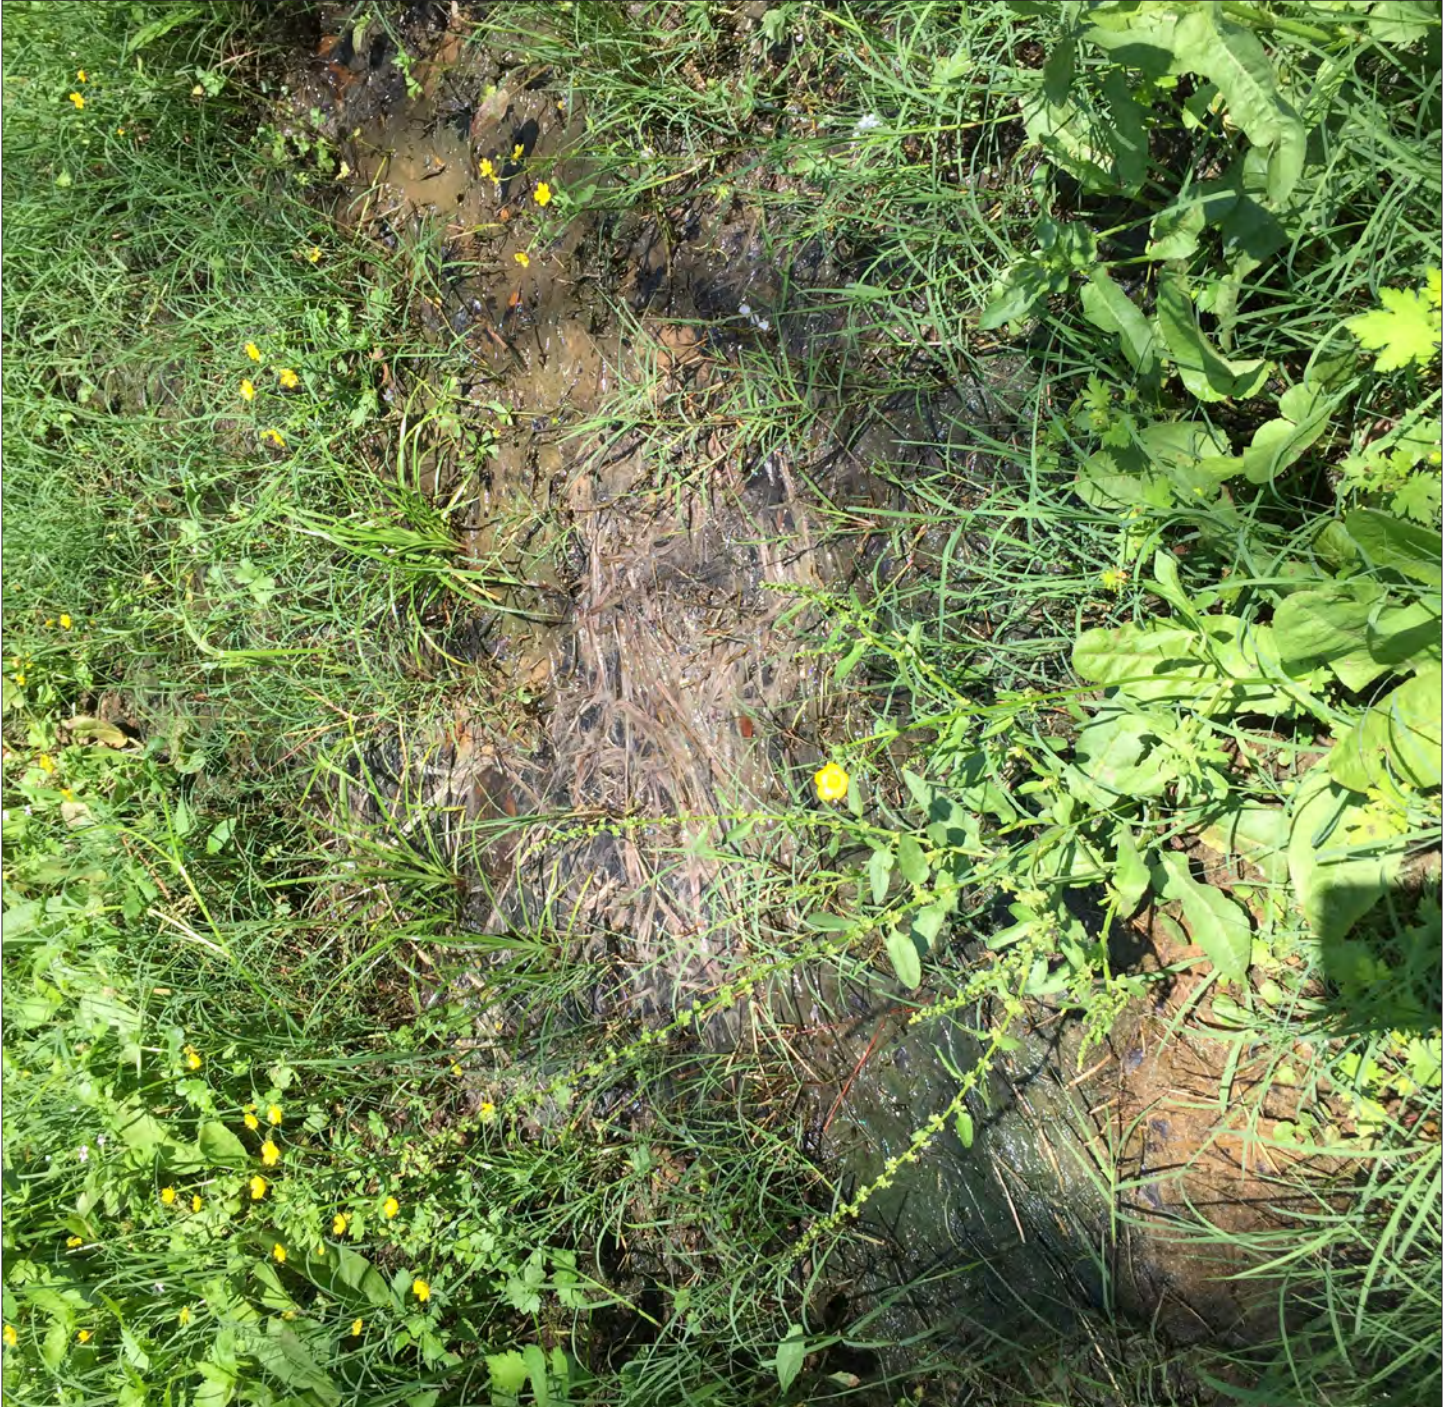
A 500-gpd system was installed at this property based upon the system design.

Site photograph of SH-001 JC property prior to OSSF installation

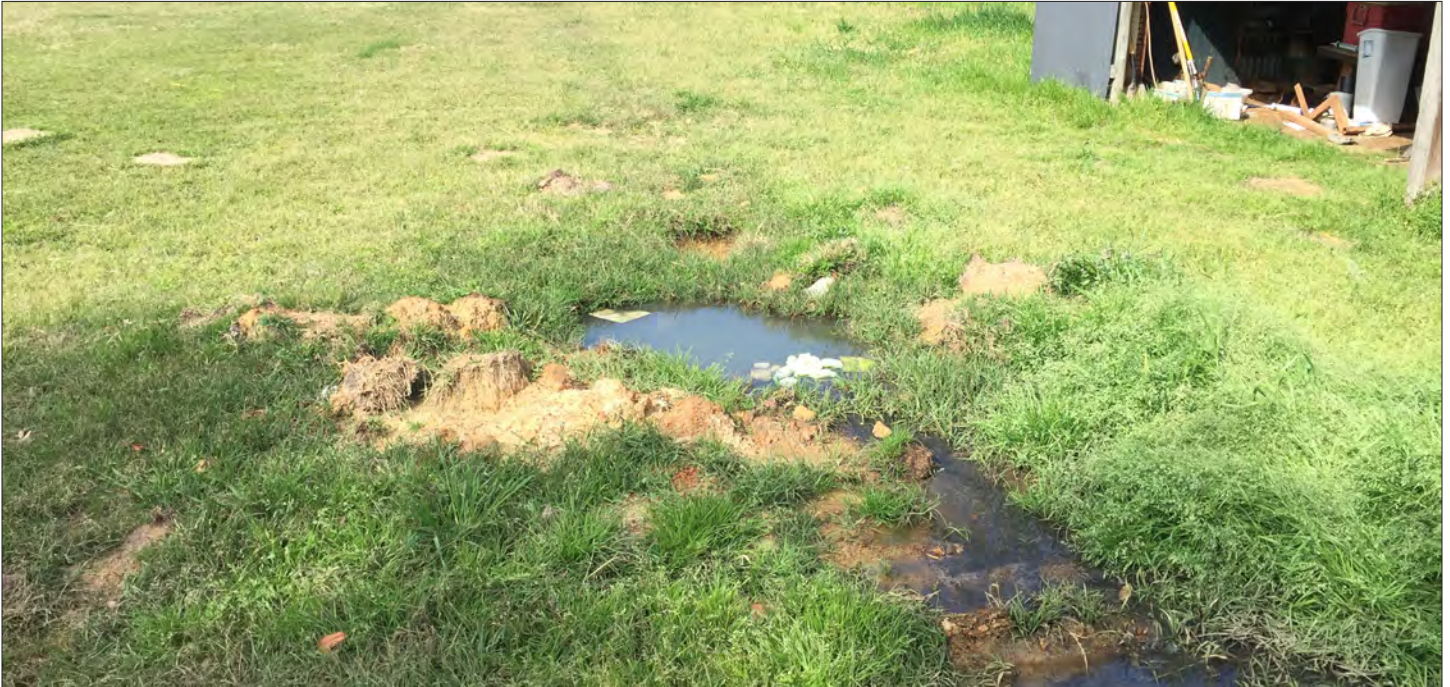
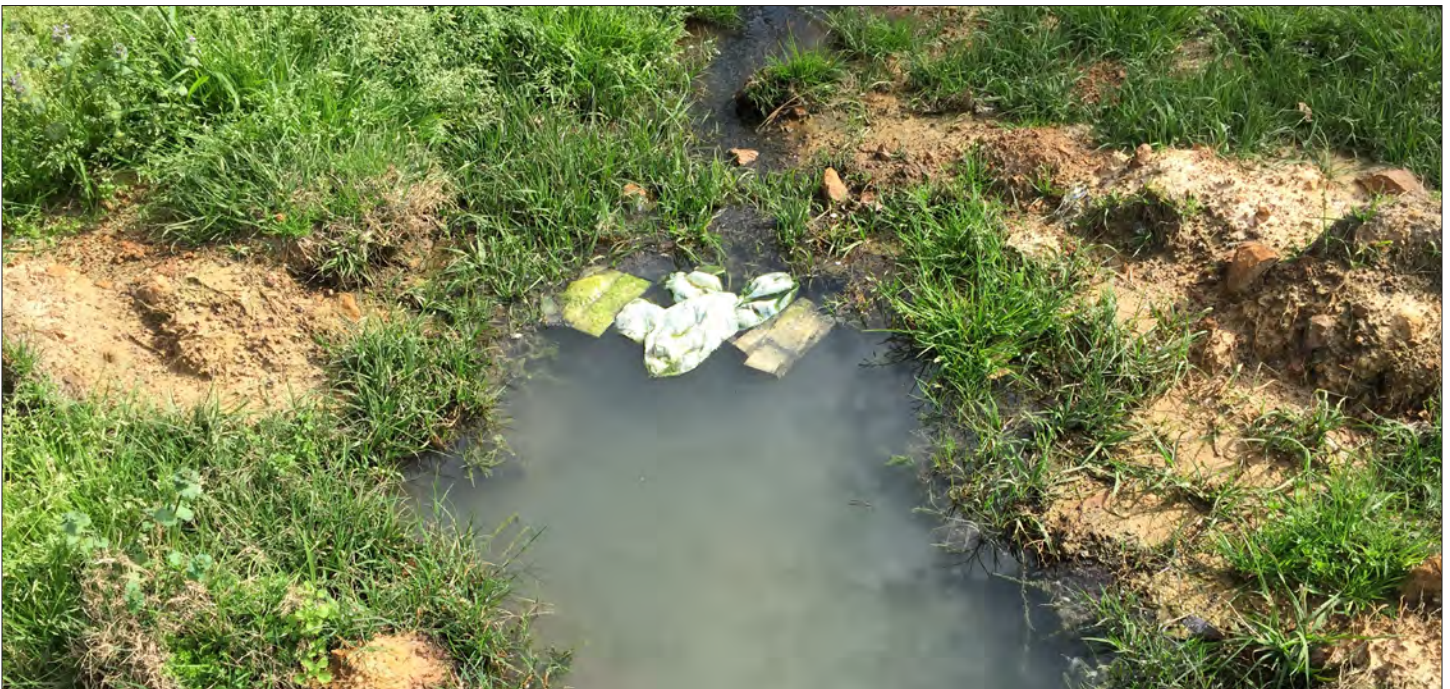
A 500-gpd system was installed at this property based upon the system design. The existing conventional system was pumped and closed.

Site photographs of NAC-005 RG property prior to OSSF installation

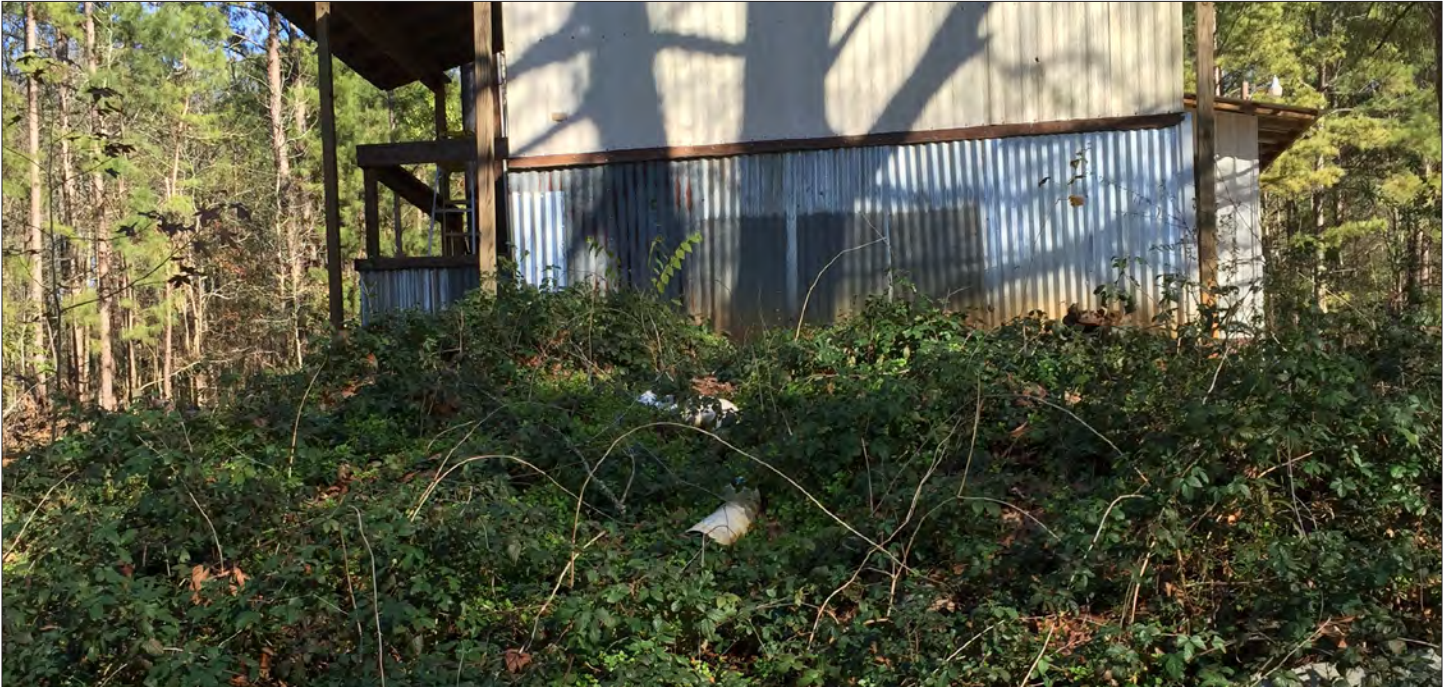
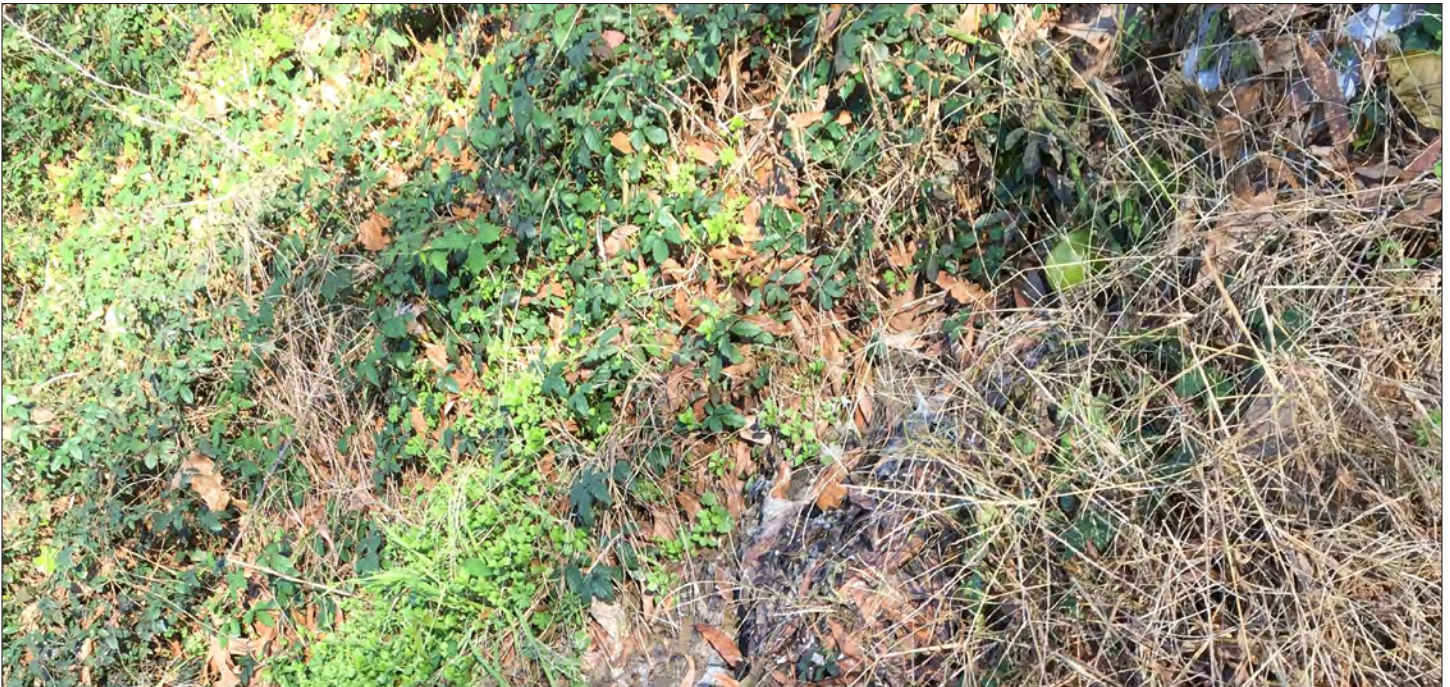
A 500-gpd system was installed at this property based upon the system design.

Site photographs of SH-002 CWC property prior to OSSF installation

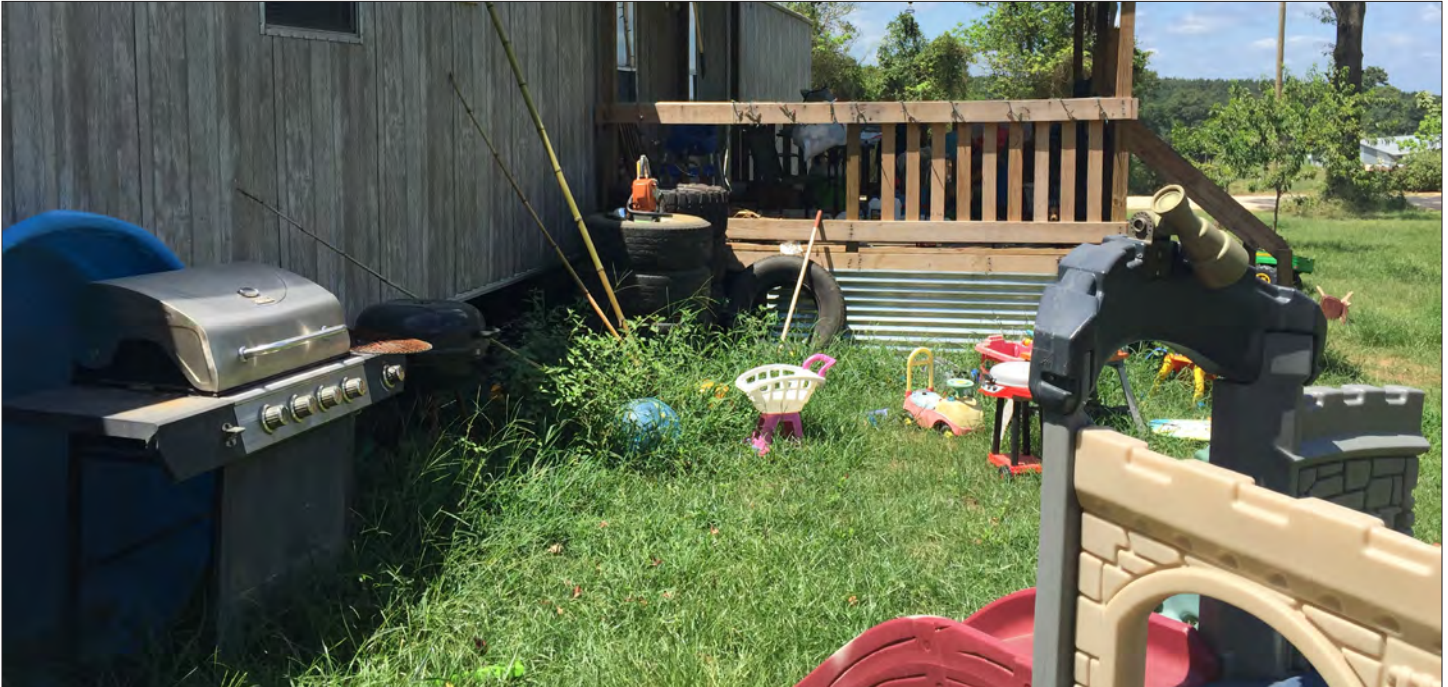
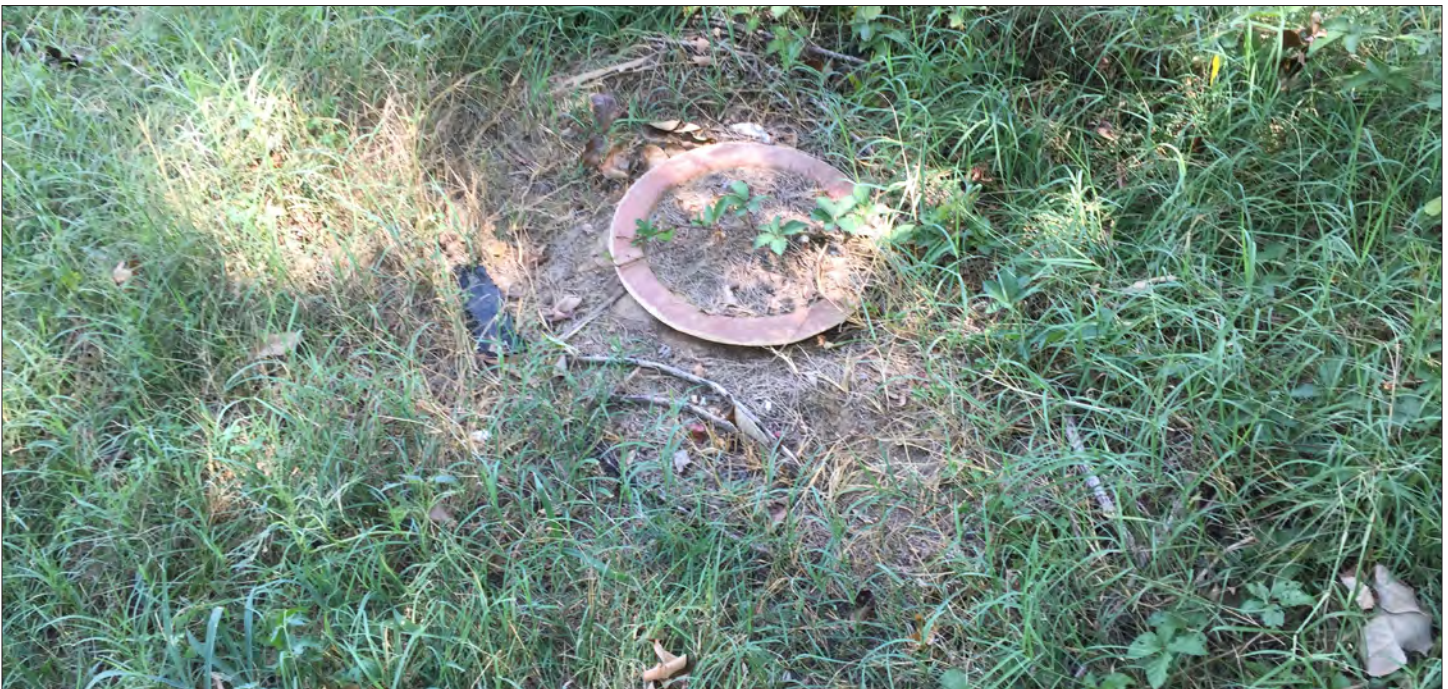
A 500-gpd system was installed at this property based upon the system design. The existing system was pumped and closed.

Site photographs of SA-001 BF property prior to OSSF installation

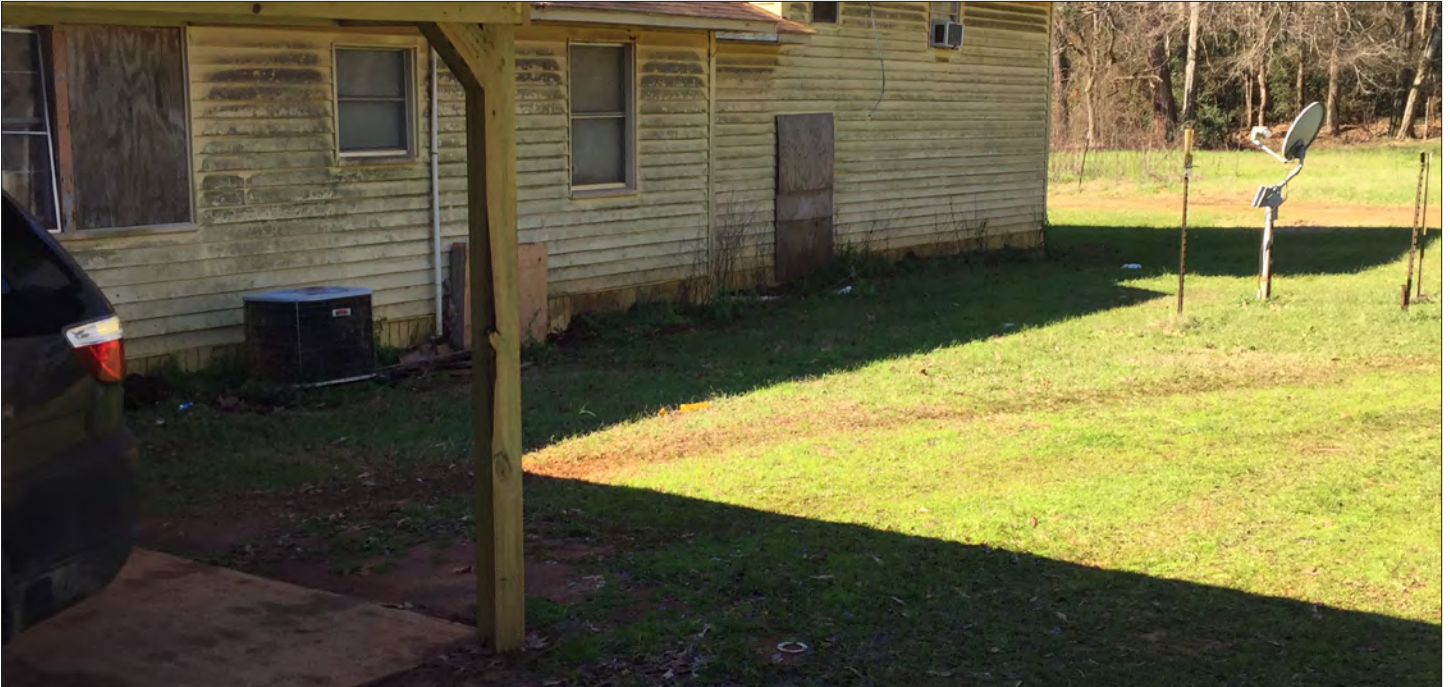
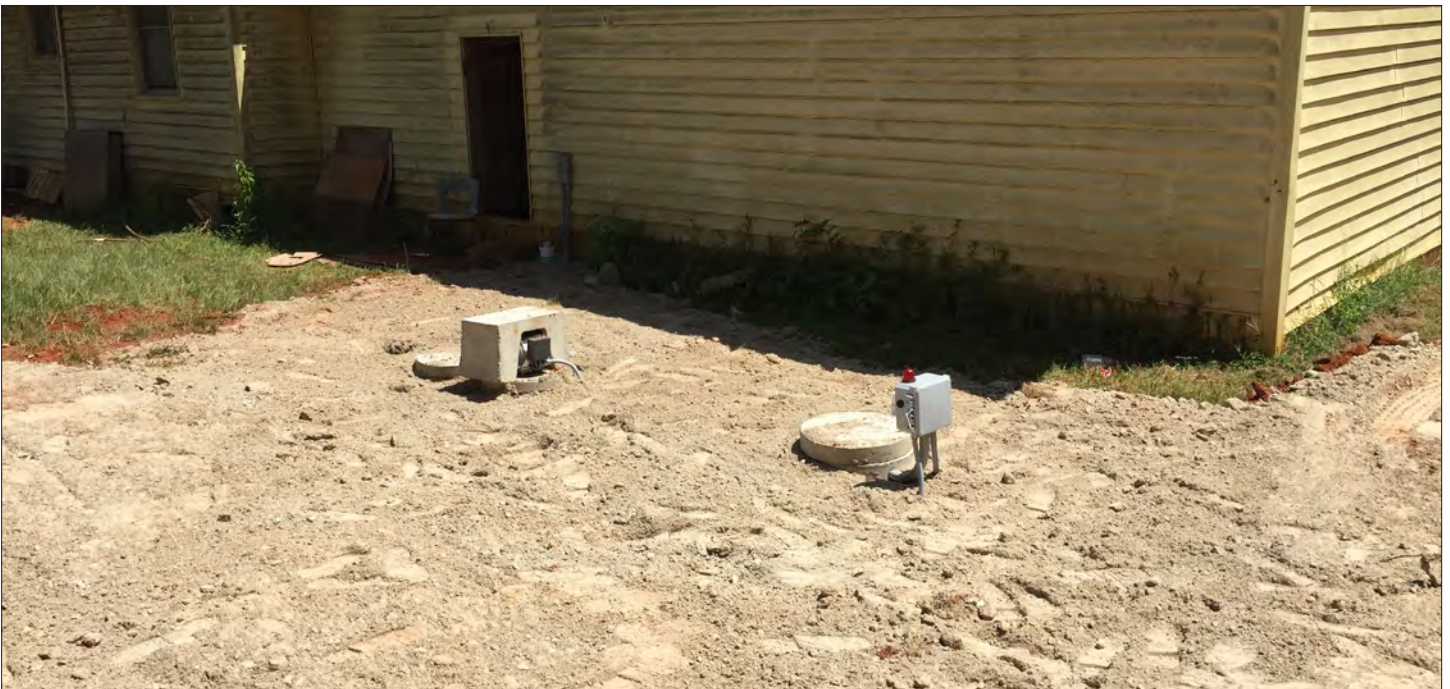
A 500-gpd system was installed at this property based upon the system design. The existing system was pumped and closed.

Site photographs of SA-003 IPL property at inspection

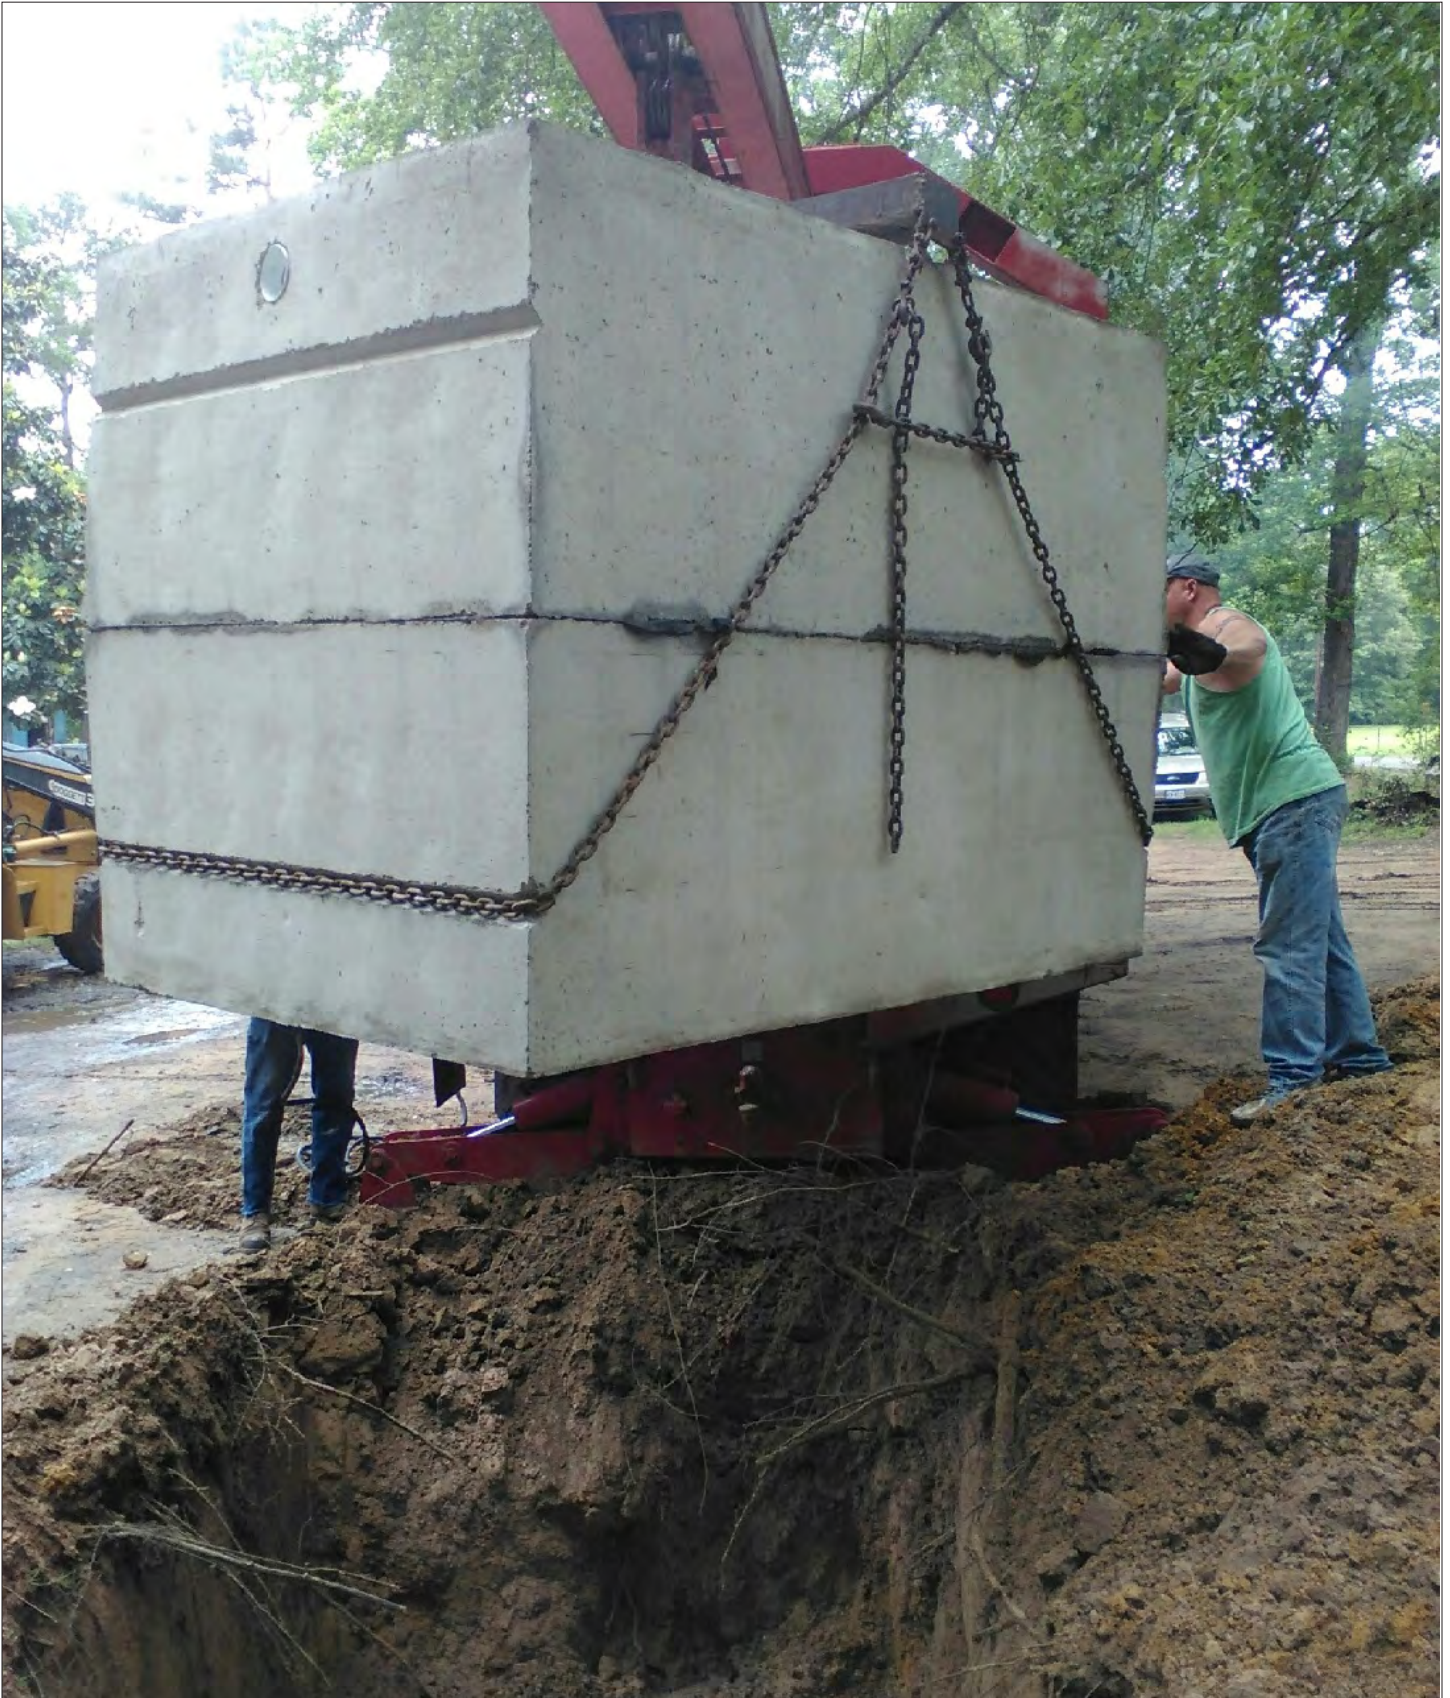
Site photograph of SA-003 IPL property during OSSF installation

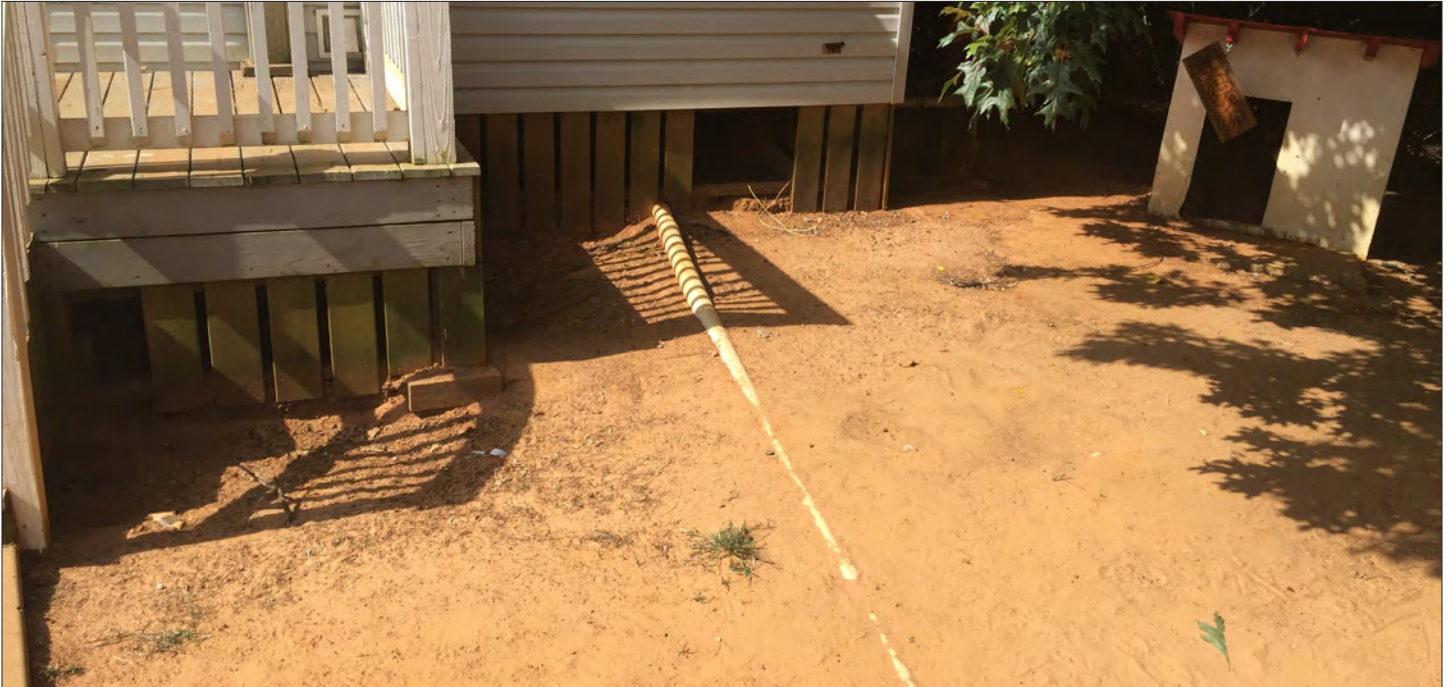
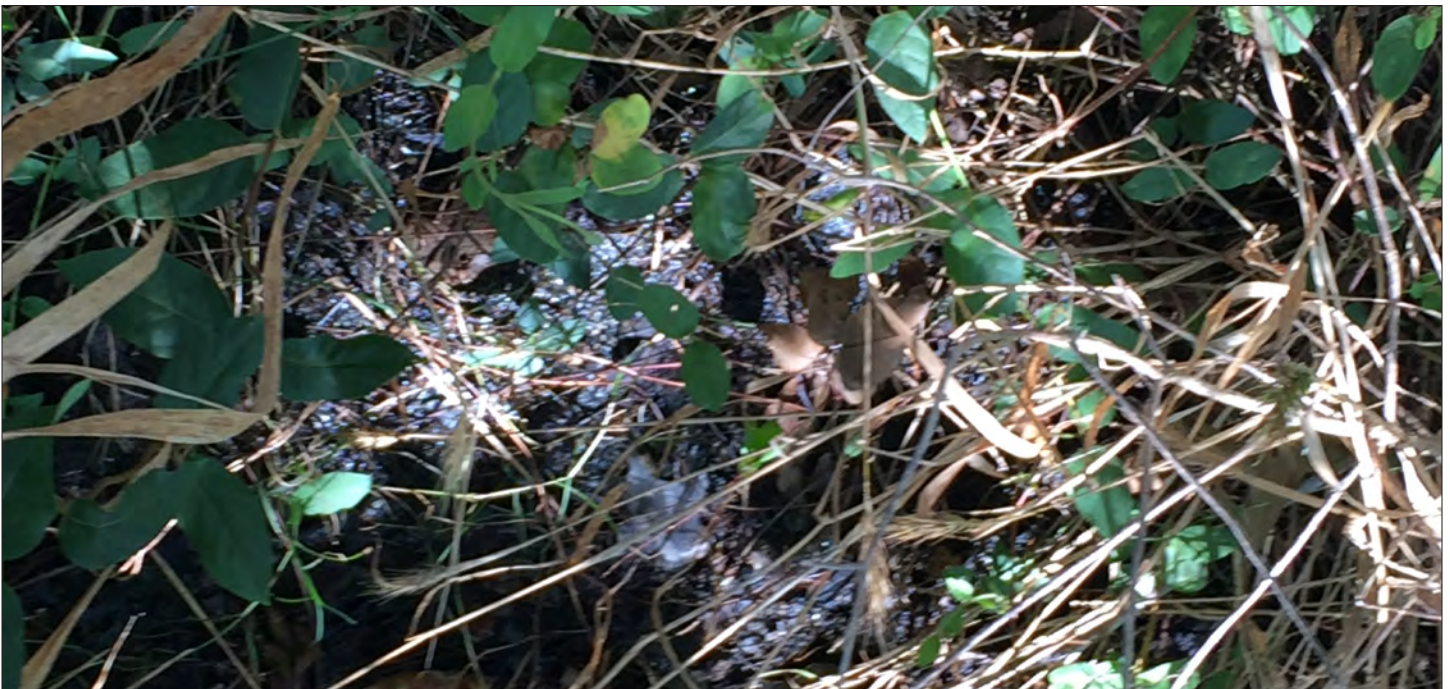
Because of the number of occupants (2 adults and 5 children), it was necessary to install a 750-gpd system to meet the estimated daily flow. The existing system was pumped and closed.

Site photographs of SA-004 CC property prior to OSSF installation

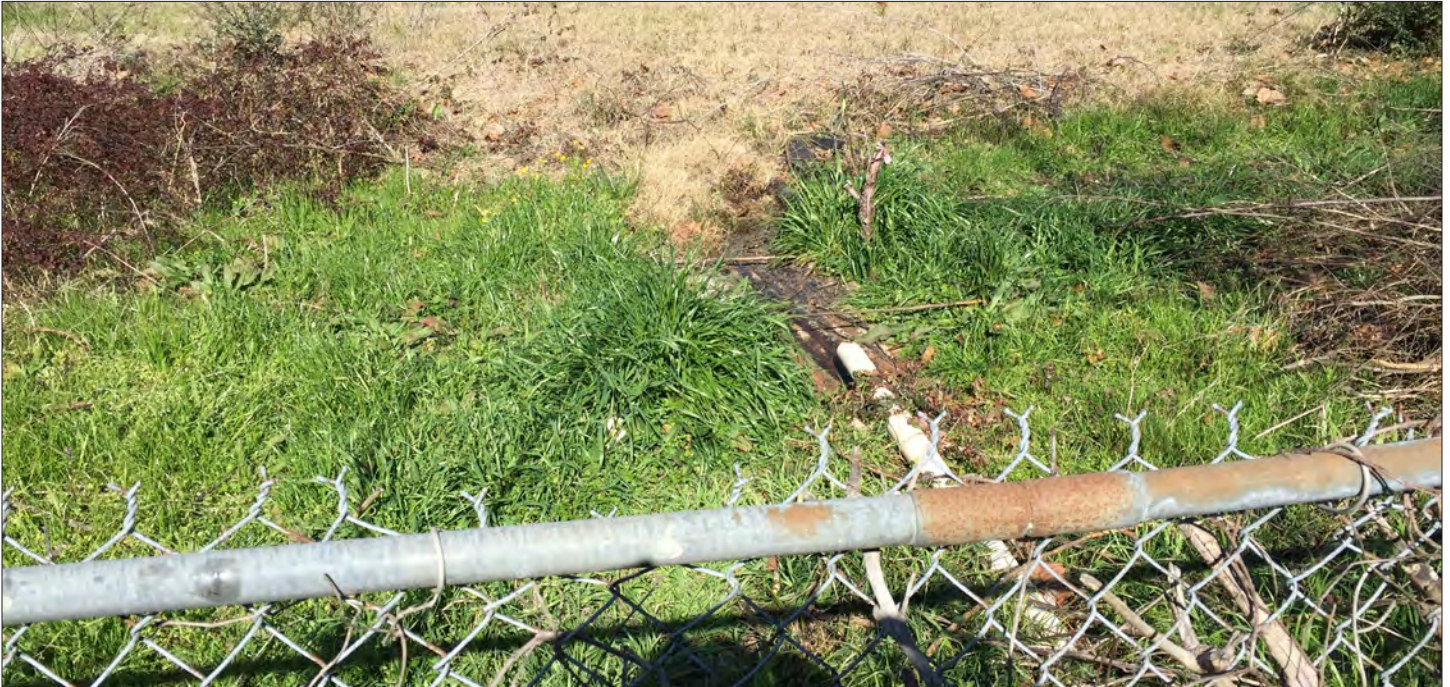
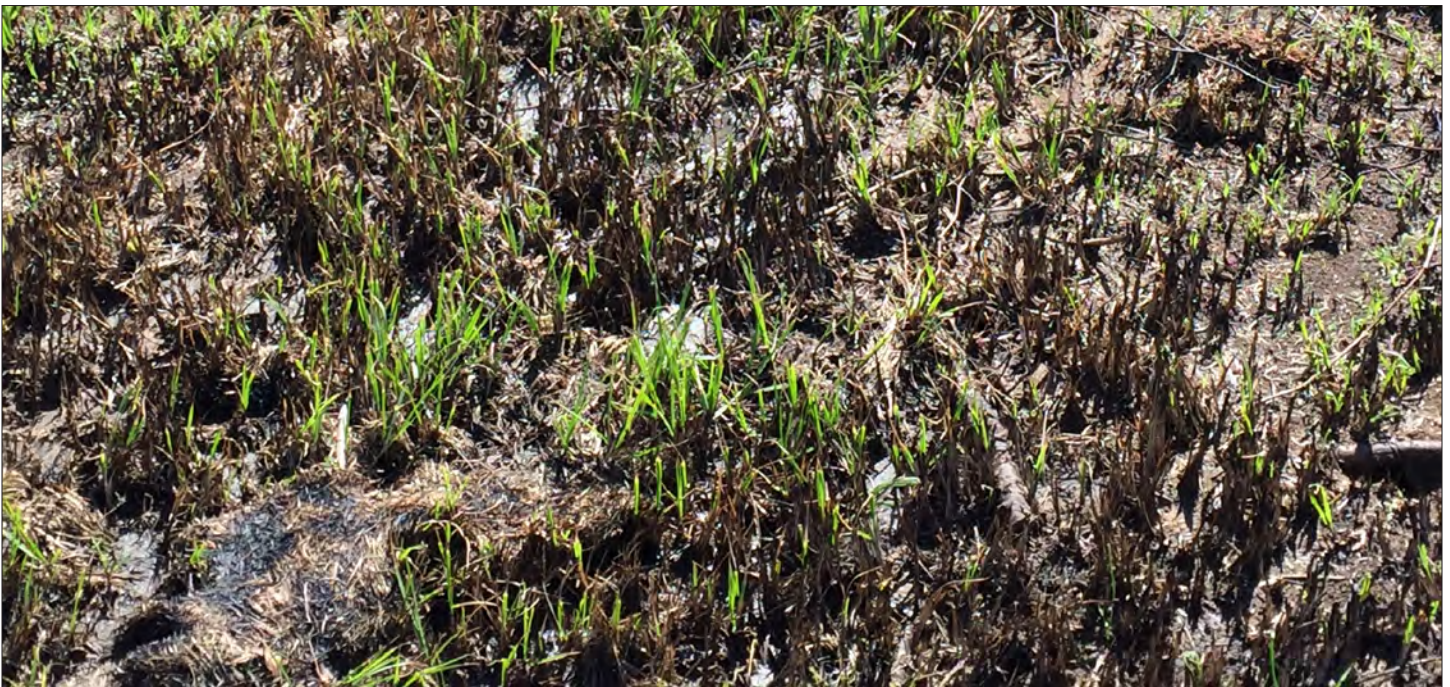
A 500-gpd system was installed at this property based upon the system design. The existing system was pumped and closed.

Site photographs of SA-005 EC property prior to OSSF installation
