Lake Sam Rayburn On-Site Sewage Facility (OSSF) Program Support and Attoyac Bayou OSSF Remediation FINAL REPORT

FINAL REPORT August 2016

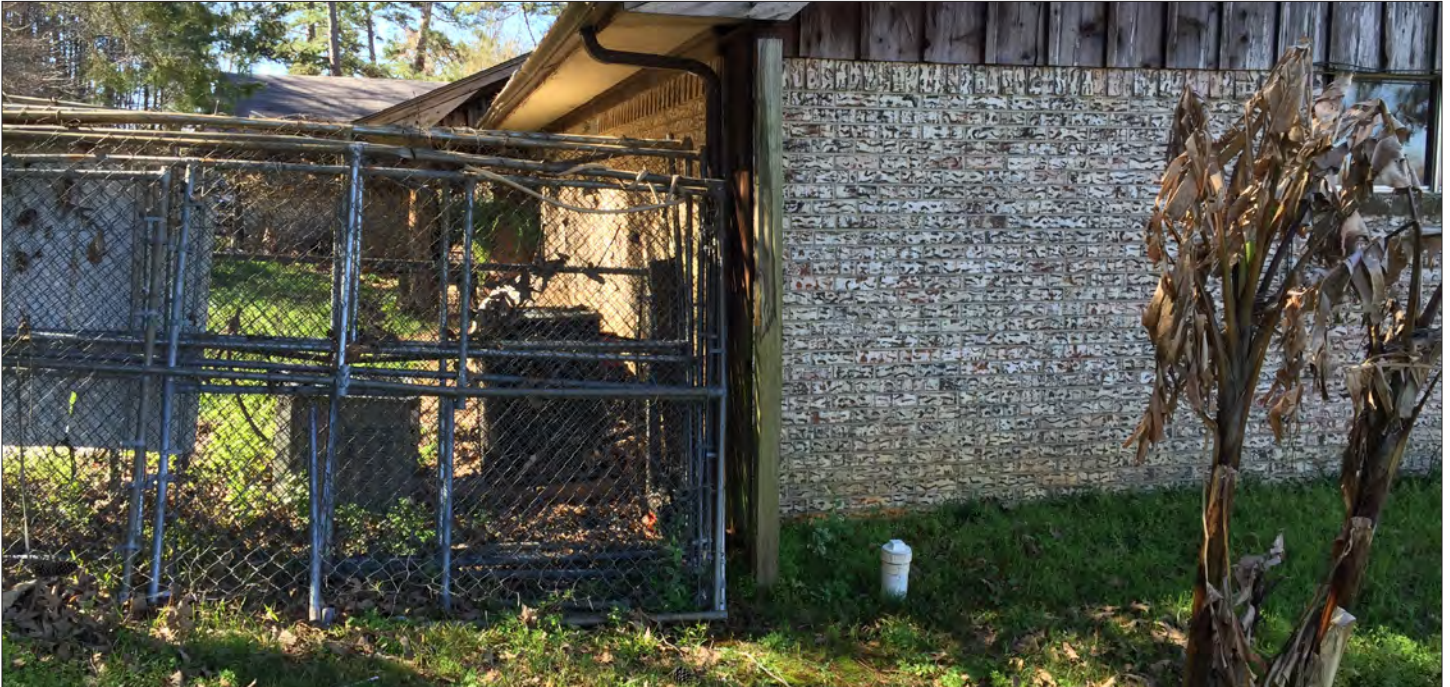
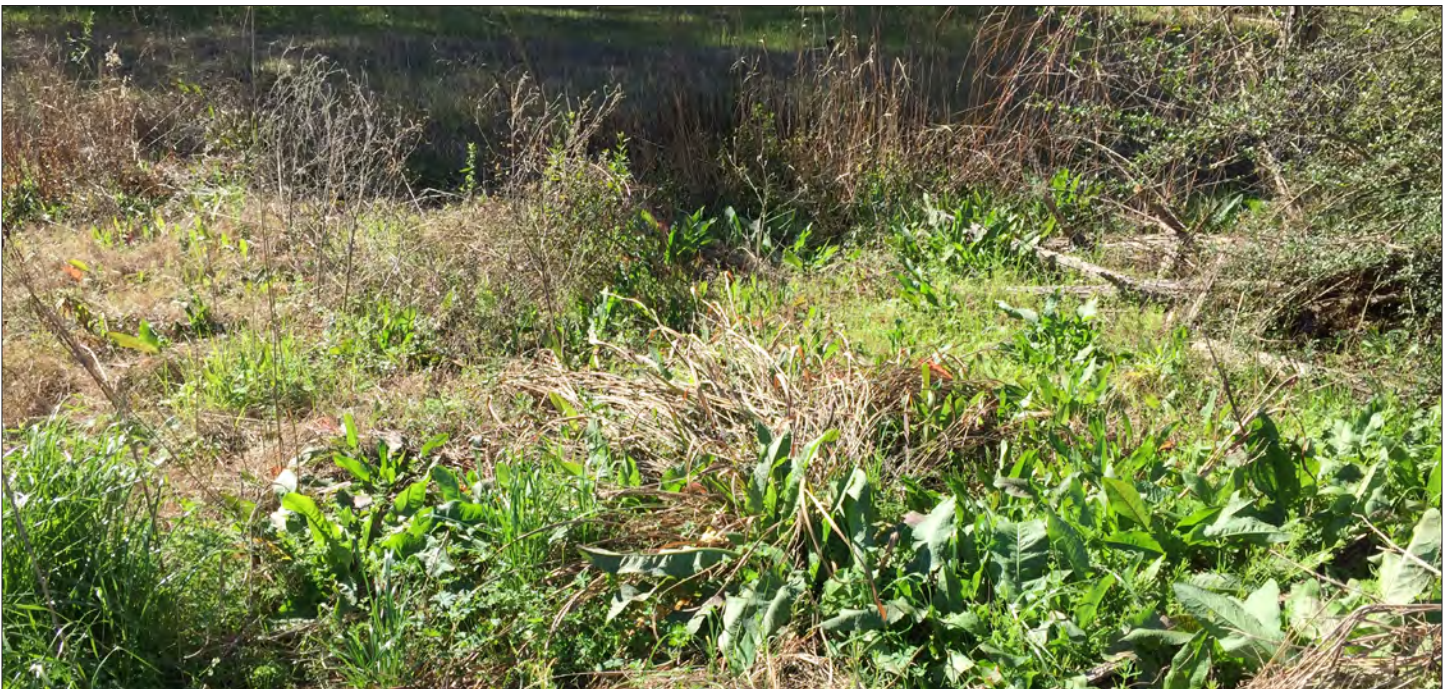
A 500-gpd system was installed at this property based upon the system design. The existing system was pumped and closed.

Site photographs of NAC-007 NC property prior to OSSF installation

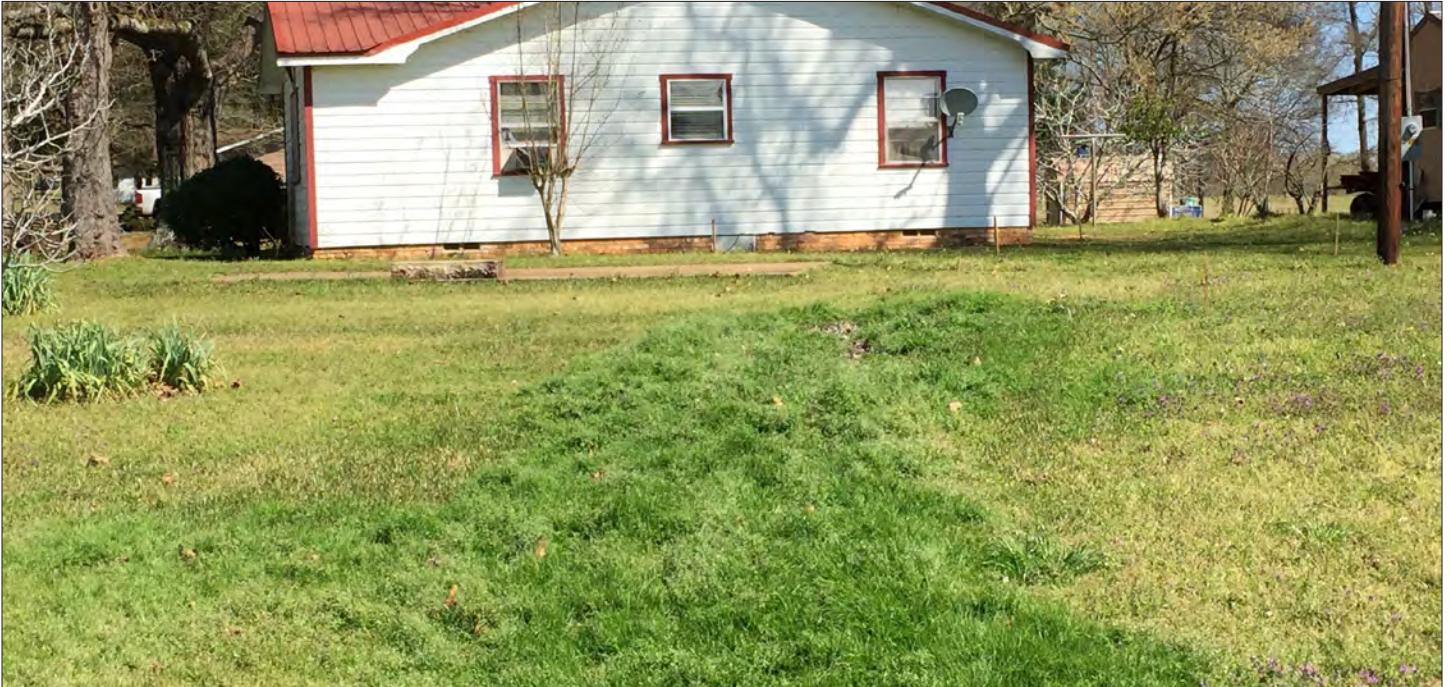
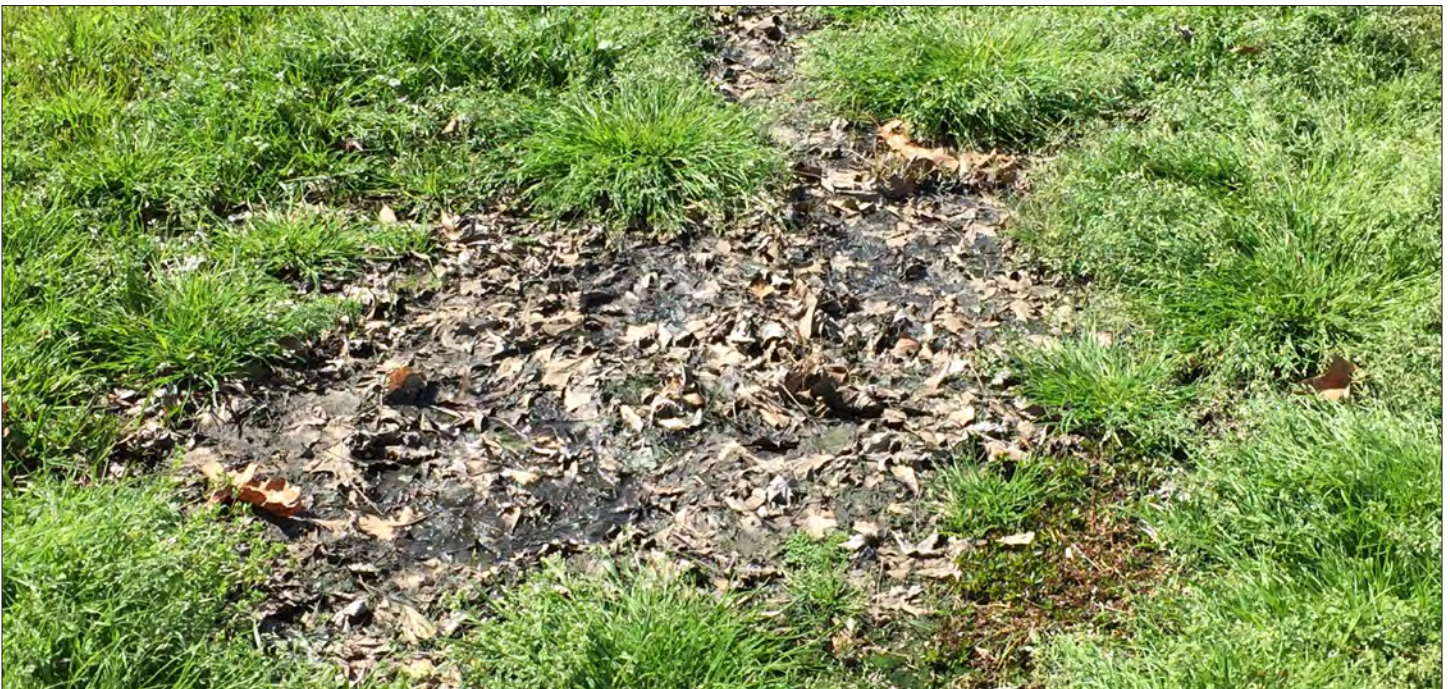
A 500-gpd system was installed at this property based upon the system design. The existing system was pumped and closed.

Site photographs of SA-006 DB property prior to OSSF installation

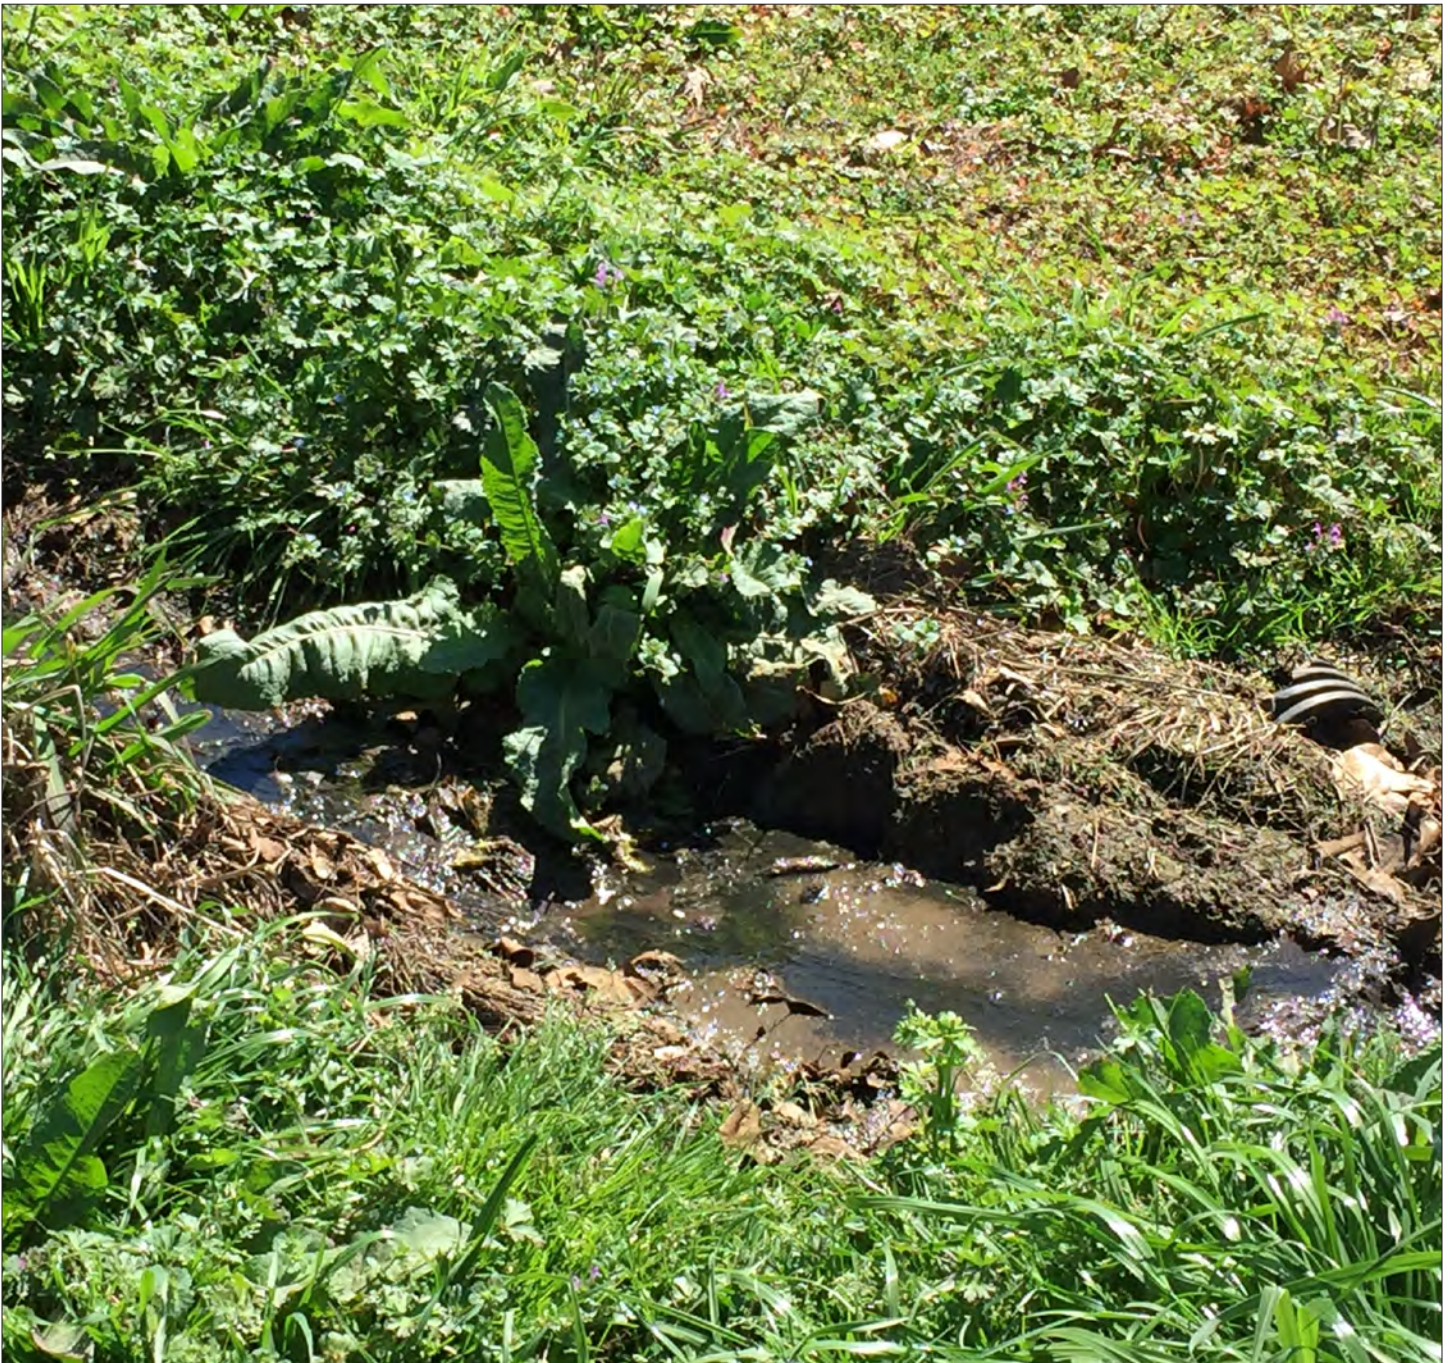
A 500-gpd system was installed at this property based upon the system design.

Site photograph of SA-007 KB property prior to OSSF installation

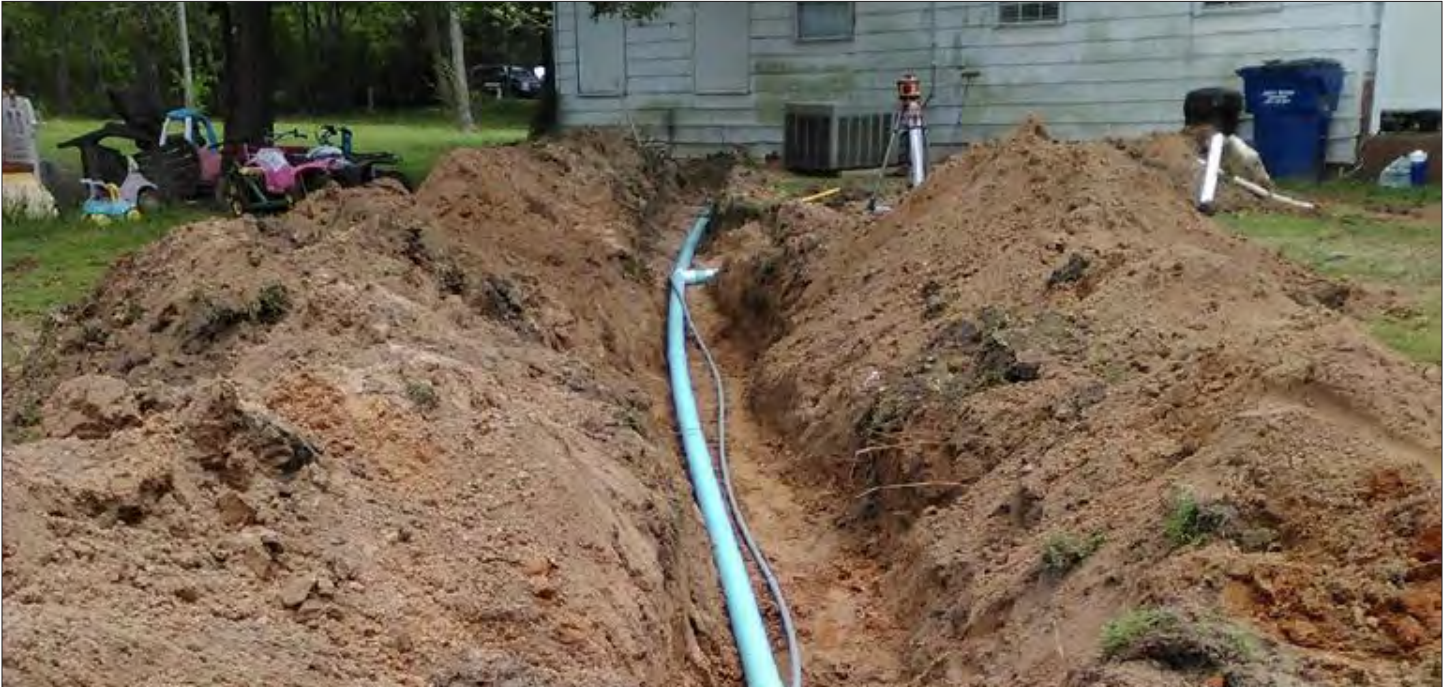
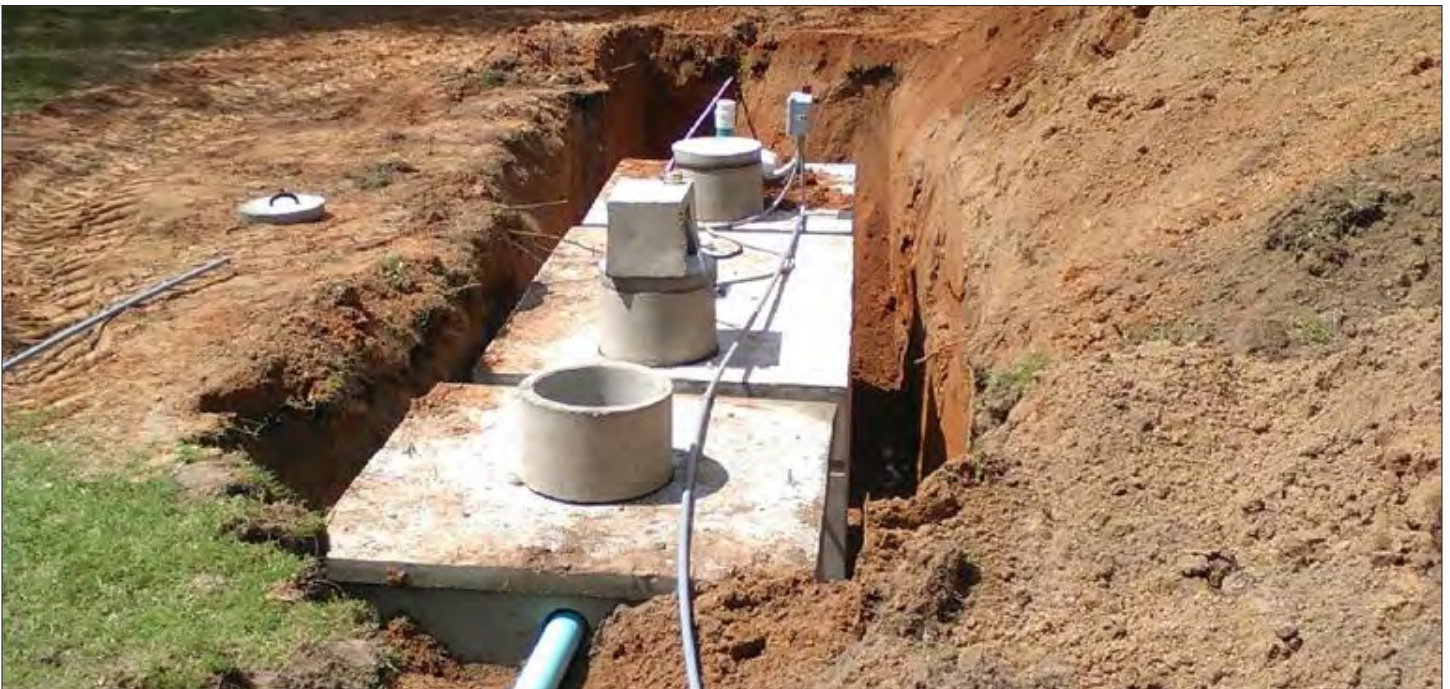
Based upon the usage as a single family residence and daycare facility, a 750-gpd system was installed. The existing system was pumped and closed.

Site photographs of NAC-008 JP property during OSSF installation

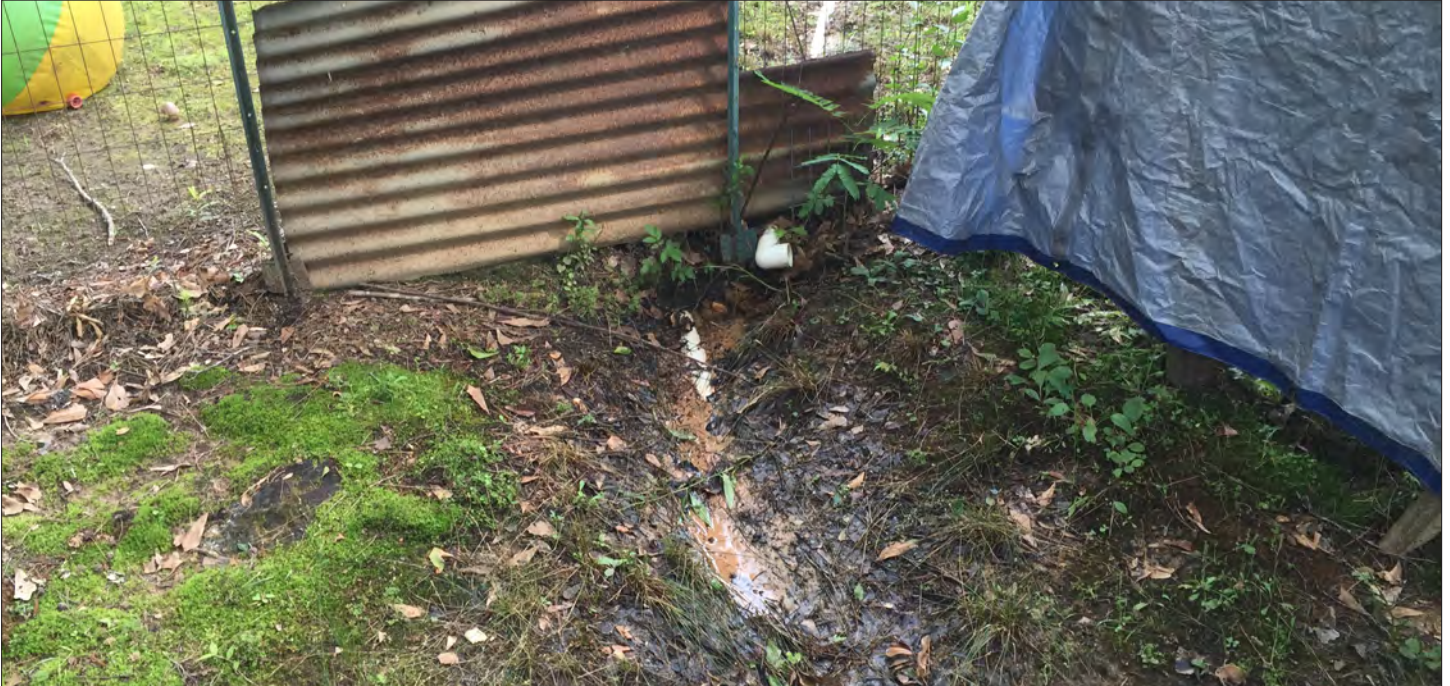
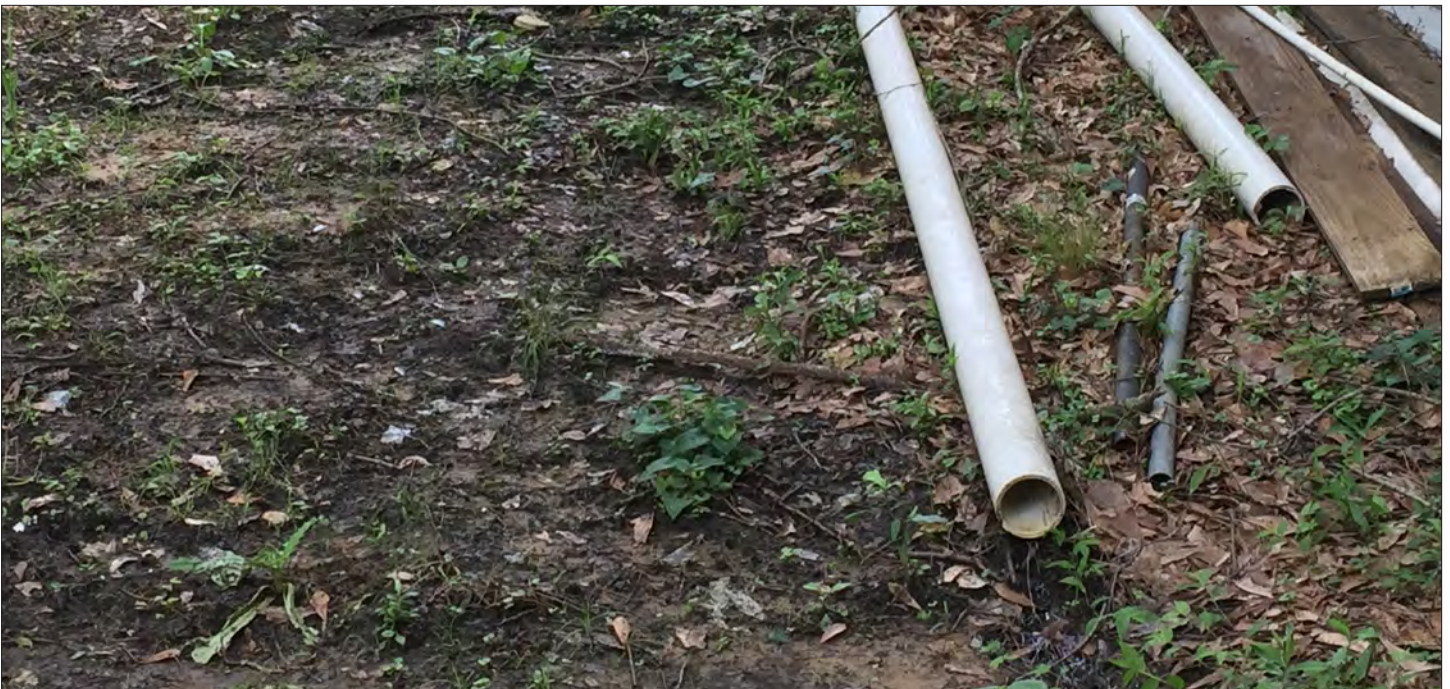
A 500-gpd system was installed at this property based upon the system design. The existing system was pumped and closed.

Site photographs of NAC-010 CM property prior to OSSF installation

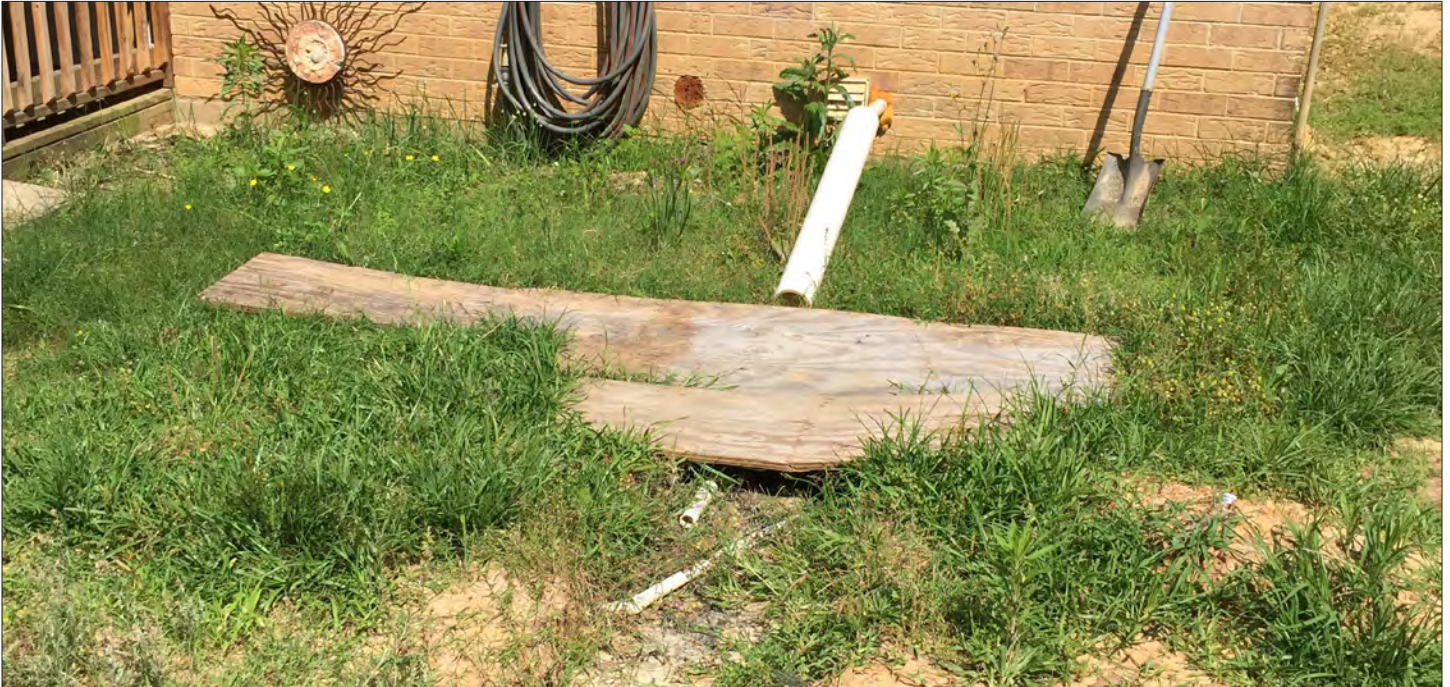
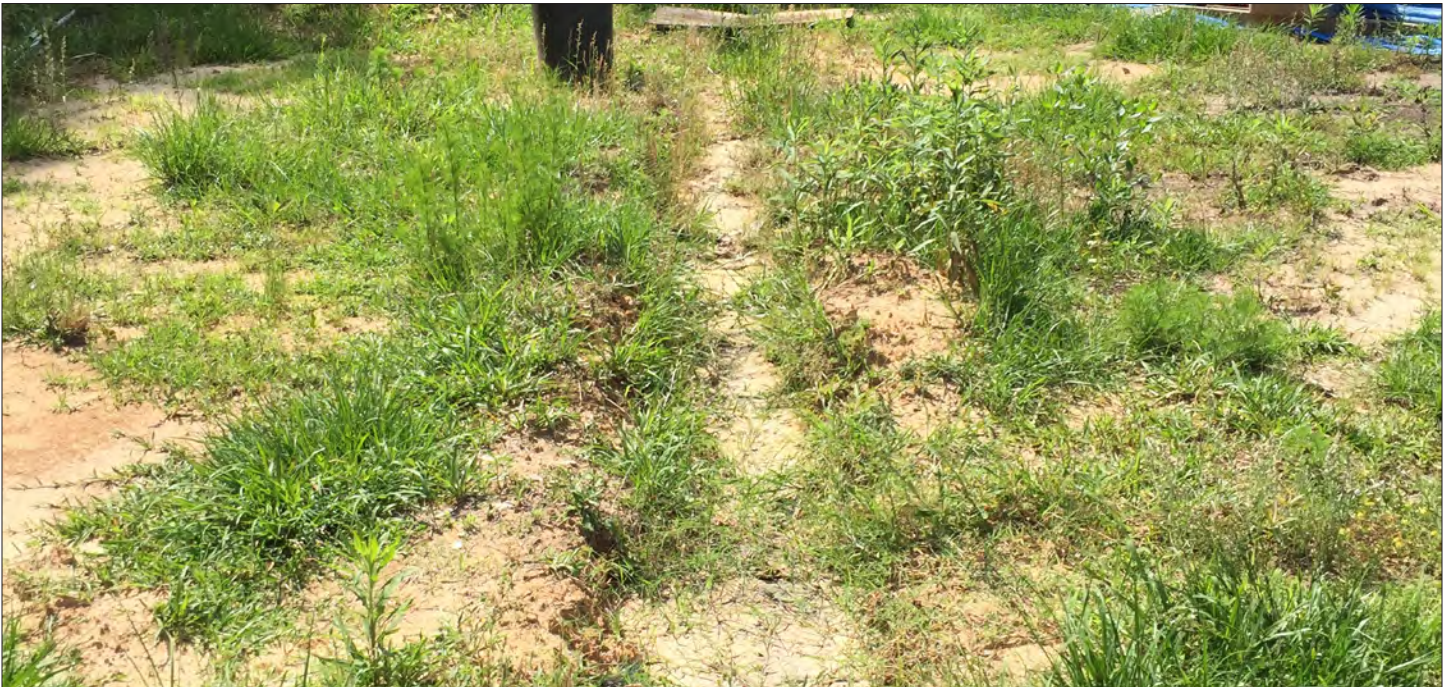
A 500-gpd system was installed at this property based upon the system design. The existing system was pumped and closed.

Site photographs of NAC-011 PR property prior to OSSF installation

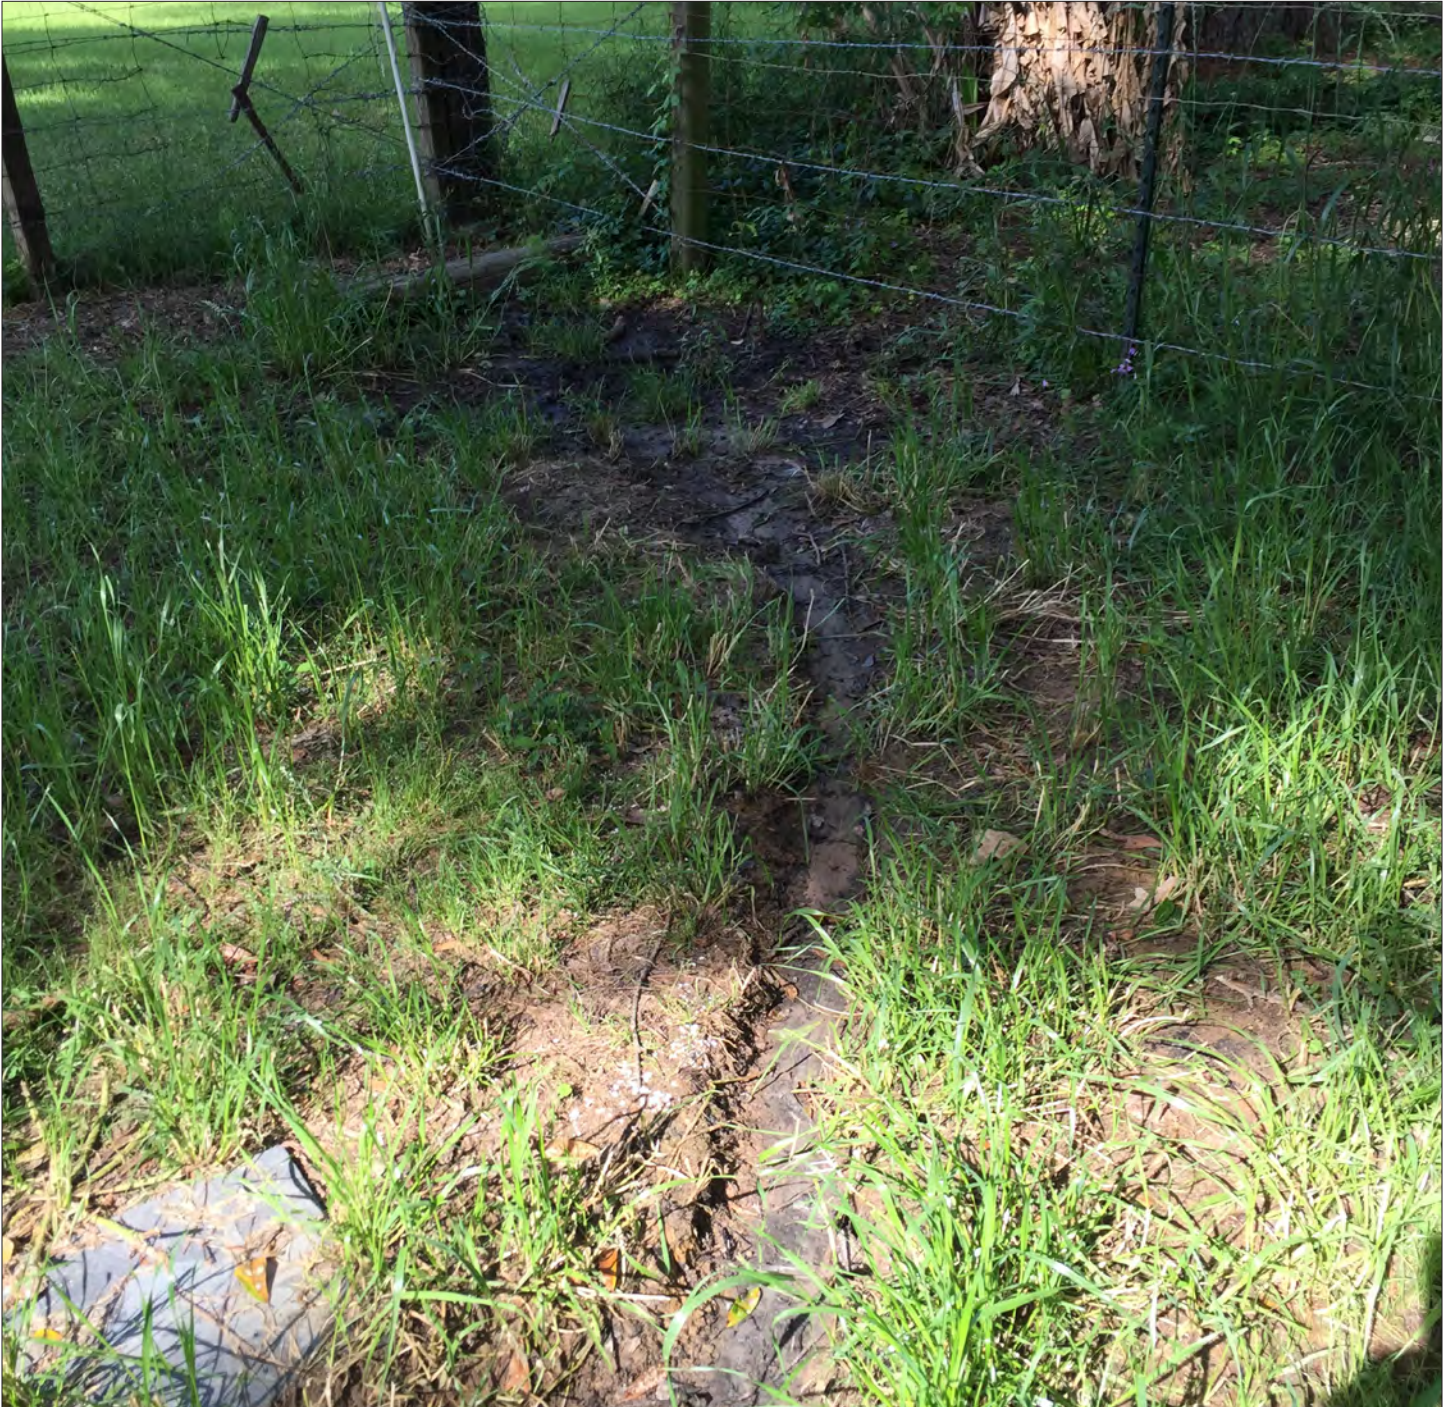
A 500-gpd system was installed at this property based upon the system design. The existing system was pumped and closed.

Site photographs of NAC-012 RE property prior to OSSF installation

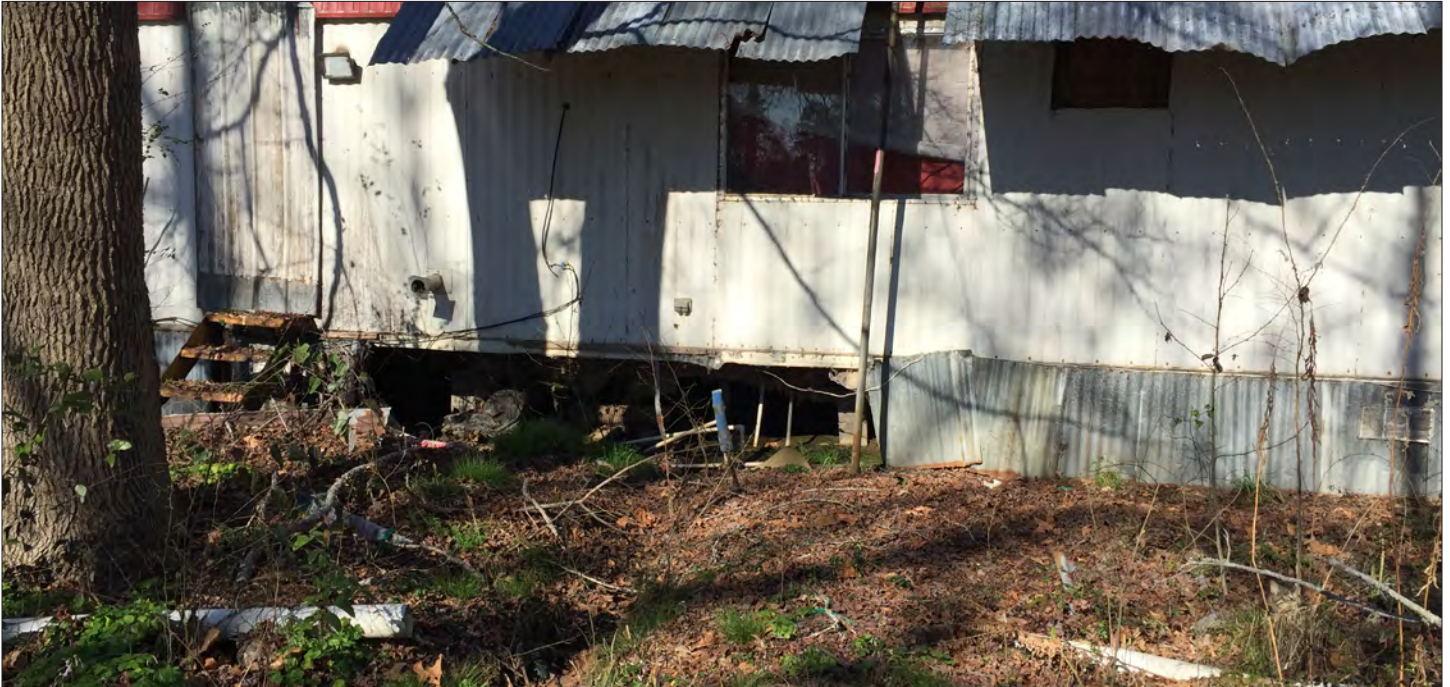
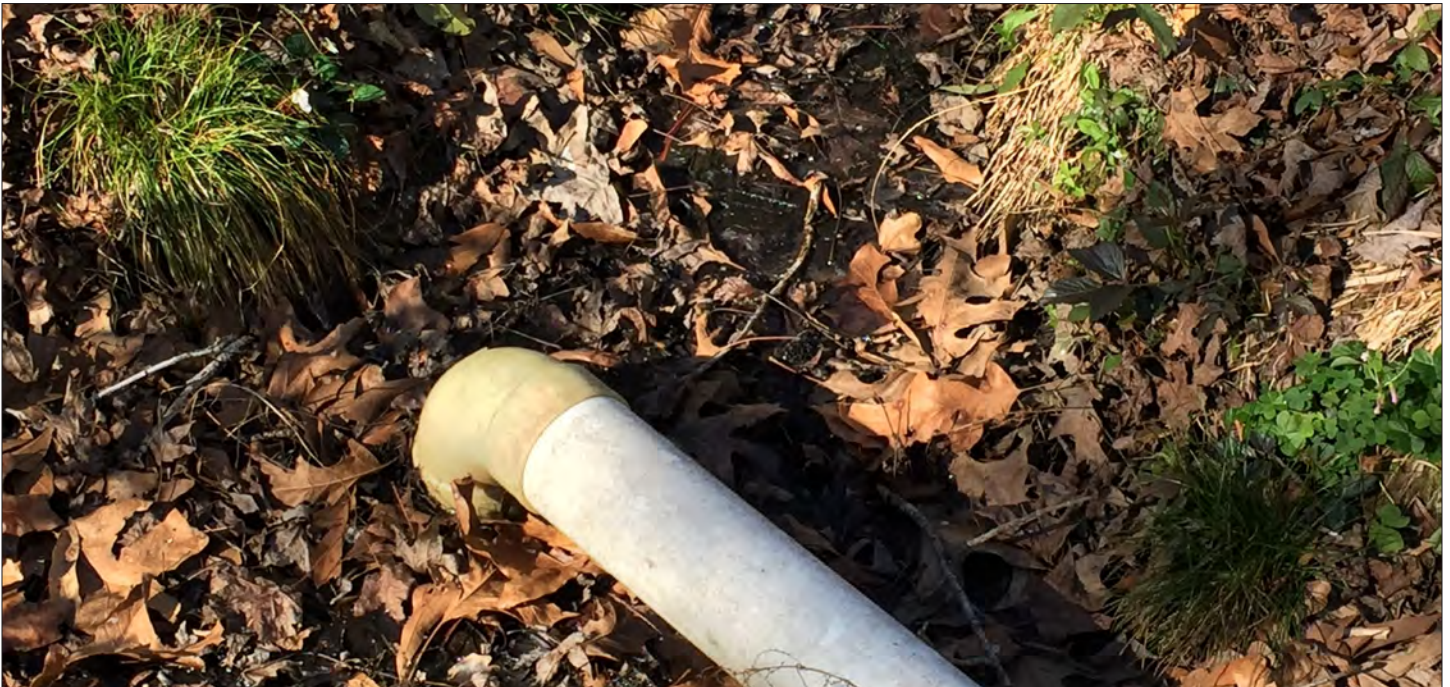
A 500-gpd system was installed at this property based upon the system design. The existing system was pumped and closed.

Site photographs of NAC-013 JE property prior to OSSF installation

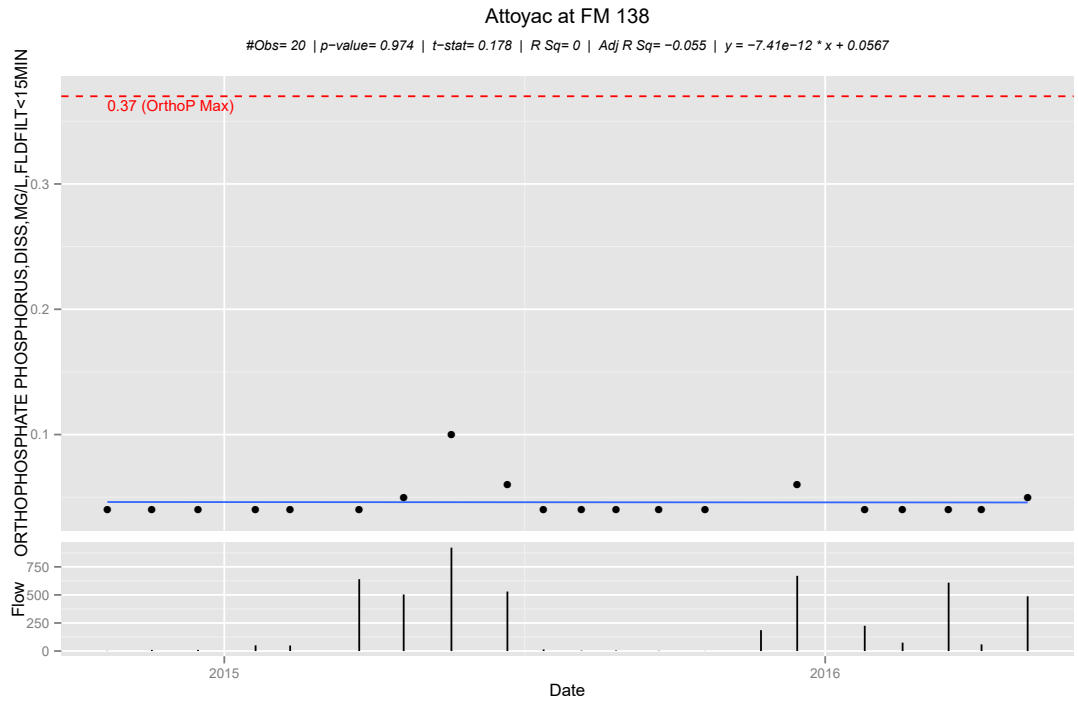
Monitoring Station 20841 - Attoyac Bayou at FM 138

All **Dissolved Orthophosphorus** results were low, with the majority of results reported as less than the limit of quantitation. Results for one sampling event were not reported by the laboratory due to a quality control sample failure.

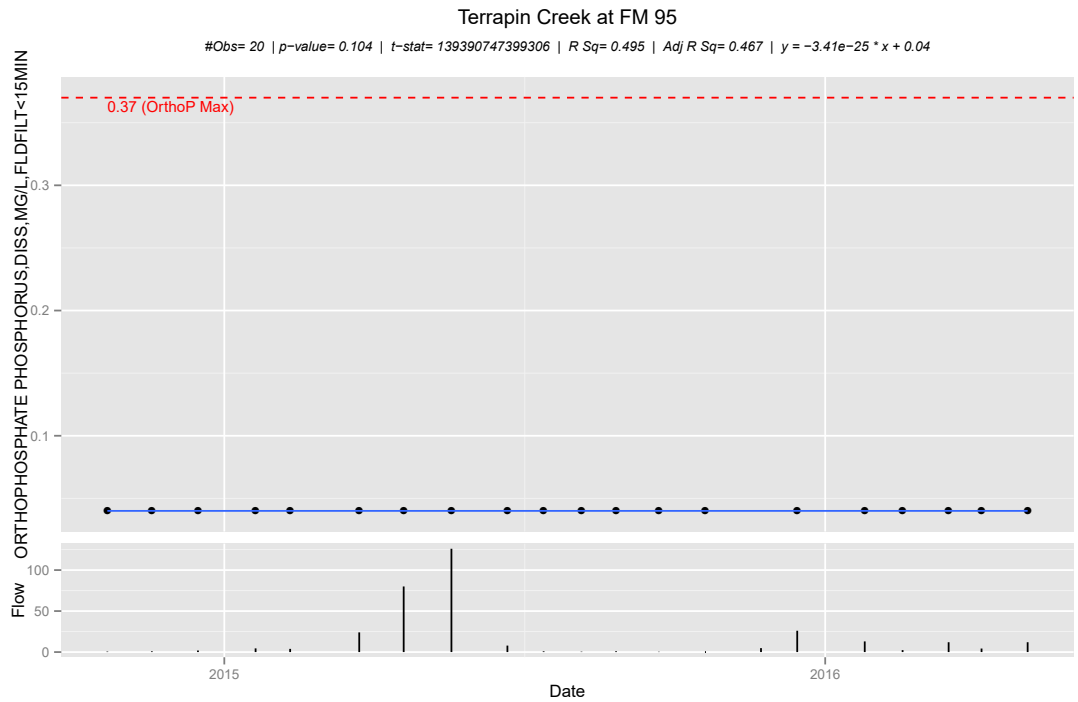
Monitoring Station 16084 - Terrapin Creek at SH 95

All **Dissolved Orthophosphorus** results at this monitoring station were reported as less than the limit of quantitation. Results for one sampling event were not reported by the laboratory due to a quality control sample failure.
