Lake Eastex Planning Studies *Final Report*

Angelina and Neches River Authority
and
Texas Water Development Board

**ANGELINA AND NECHES RIVER AUTHORITY
LAKE EASTEX PLANNING STUDIES**

FINAL REPORT

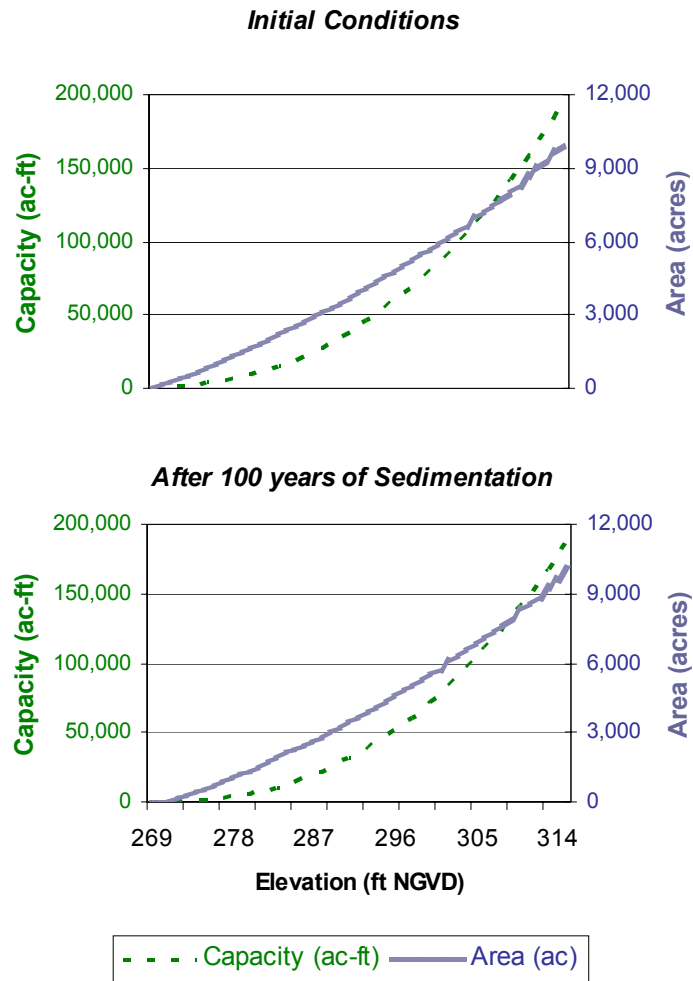
Figure 2-4. Area-Capacity Estimates for Initial and Sedimentation Conditions

The area-capacity-elevation (ACE) relationship describes both the area of land inundated by the reservoir and the volume of water contained in the reservoir for each elevation between the lowest possible water level (empty) and the conservation storage elevation. LAN (1984) developed ACE relationships to represent initial reservoir conditions and conditions after 100 years of sedimentation (Figure 2-4). Both relationships were used in this study to analyze the loss of yield in the reservoir due to sedimentation. The top of conservation storage elevation for Lake Eastex is 315 feet NGVD.

When results for original and 100 year sedimentation conditions were compared, original capacity conditions provided higher yields. This is not surprising, as sedimentation would naturally decrease the volume of water that the lake could hold. Modeling results indicated that sedimentation would result in a three to four percent decrease in yield over 100 years regardless of which return flow or bypass scenario was applied.

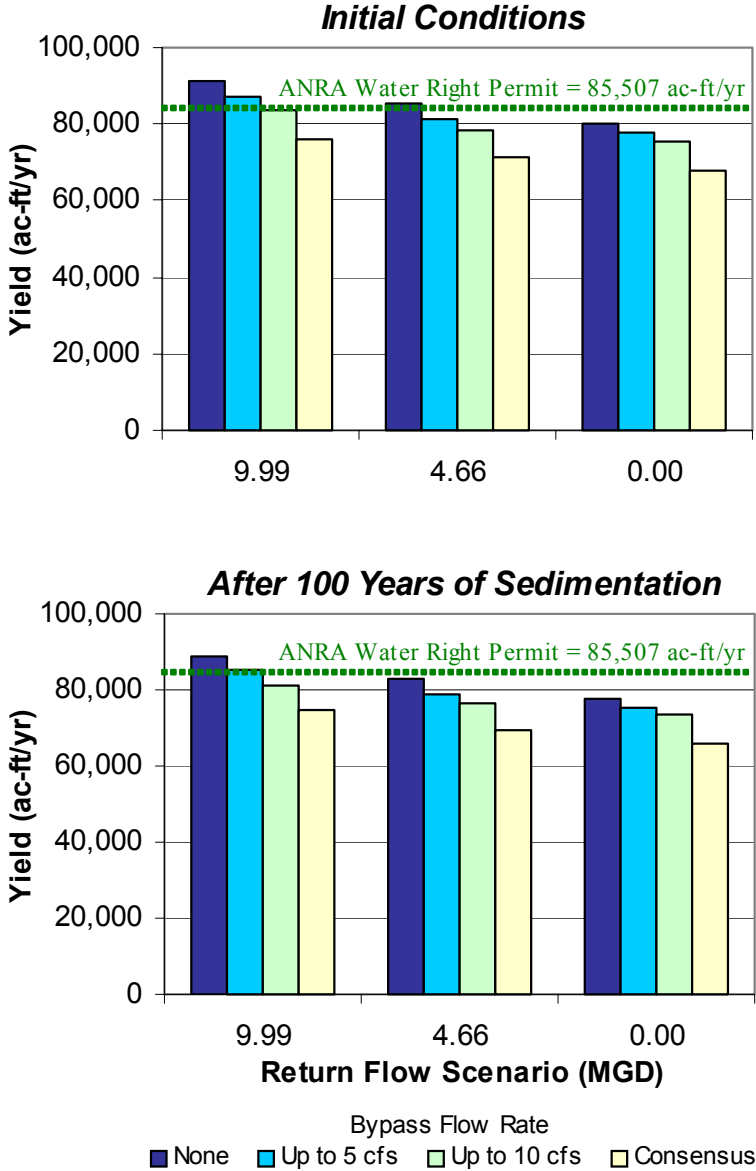
Figure 2-5 Yield of Lake Eastex Under Various Return Flow and Bypass Scenarios

Figure 2-5 illustrates the yield of Lake Eastex under each scenario analyzed in the study. Details of yield, content, and critical period for each scenario are presented in Appendix 2. As would be expected, the yield of the reservoir is highest under original conditions with maximum return flows and minimum bypasses, and decreases with decreasing return flows and increasing bypasses. Reservoir yield for each scenario is presented in Table 2-1.

Under original conditions, the maximum yield of 91,040 ac-ft/yr occurs under the scenario with maximum return flow (9.99 MGD) and no bypass flows. Decreasing return flows from 9.99 MGD to 4.66 MGD impacted reservoir yield by approximately 6 percent. Decreasing return flows from 9.99 MGD to zero MGD resulted in a decrease of approximately 12 percent in yield. Similar results were observed for sedimentation conditions.

Modeling results indicate that the selection of bypass flow methodology plays a more substantial role than return flow scenarios in determining reservoir yield. Under current conditions, maximum yield was observed under the zero bypass scenario. When bypasses were increased from zero to five cfs, reservoir yield decreased approximately four percent. When bypasses were increased from zero to ten cfs, reservoir yield decreased approximately 8 percent. When the Consensus bypass method was applied, reservoir yields decreased approximately 16 percent from the yield observed if no bypasses were made. In each case, the least impact on reservoir yield due to bypass methodology was observed under the zero MGD return flow scenario.

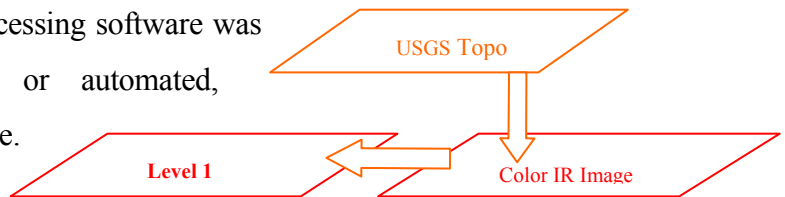
ERDAS Imagine® 8.5 image processing software was used to produce an unsupervised, or automated, classification of the tiled mosaic image. The software classified each 2-foot pixel in the mosaic into one of 30 distinct classes.
